**AUTOMATED PAVEMENT CONDITION SURVEY
FIELD MANUAL
PUBLICATION 336**

APRIL 2020

**PREPARED BY:
BUREAU OF MAINTENANCE AND OPERATIONS
ASSET MANAGEMENT DIVISION
P.O. Box 3437
HARRISBURG, PENNSYLVANIA 17105-3437
(717) 787-6899**

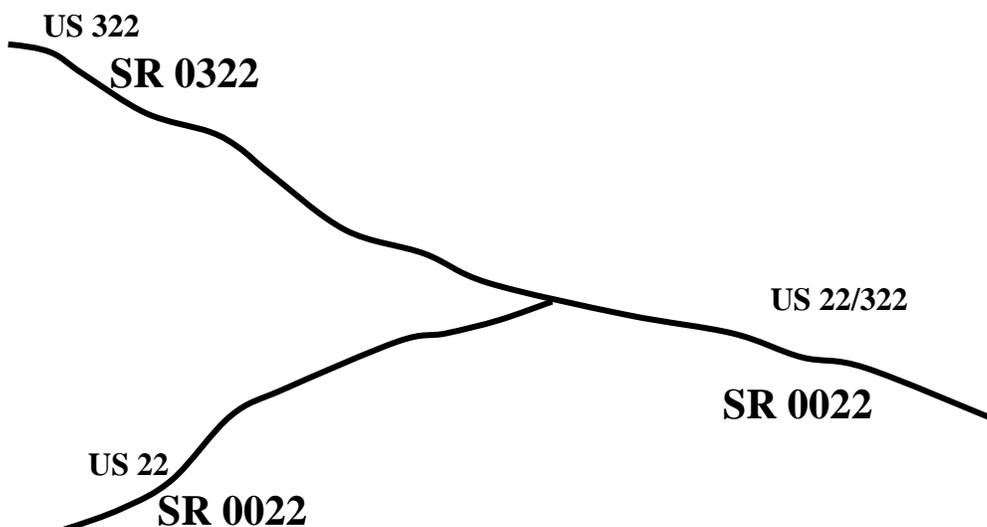
SR DESIGNATION OF SHARED ROADWAY

If the traffic routes are the same hierarchy class, then the SR number is assigned the lower numbered traffic route.

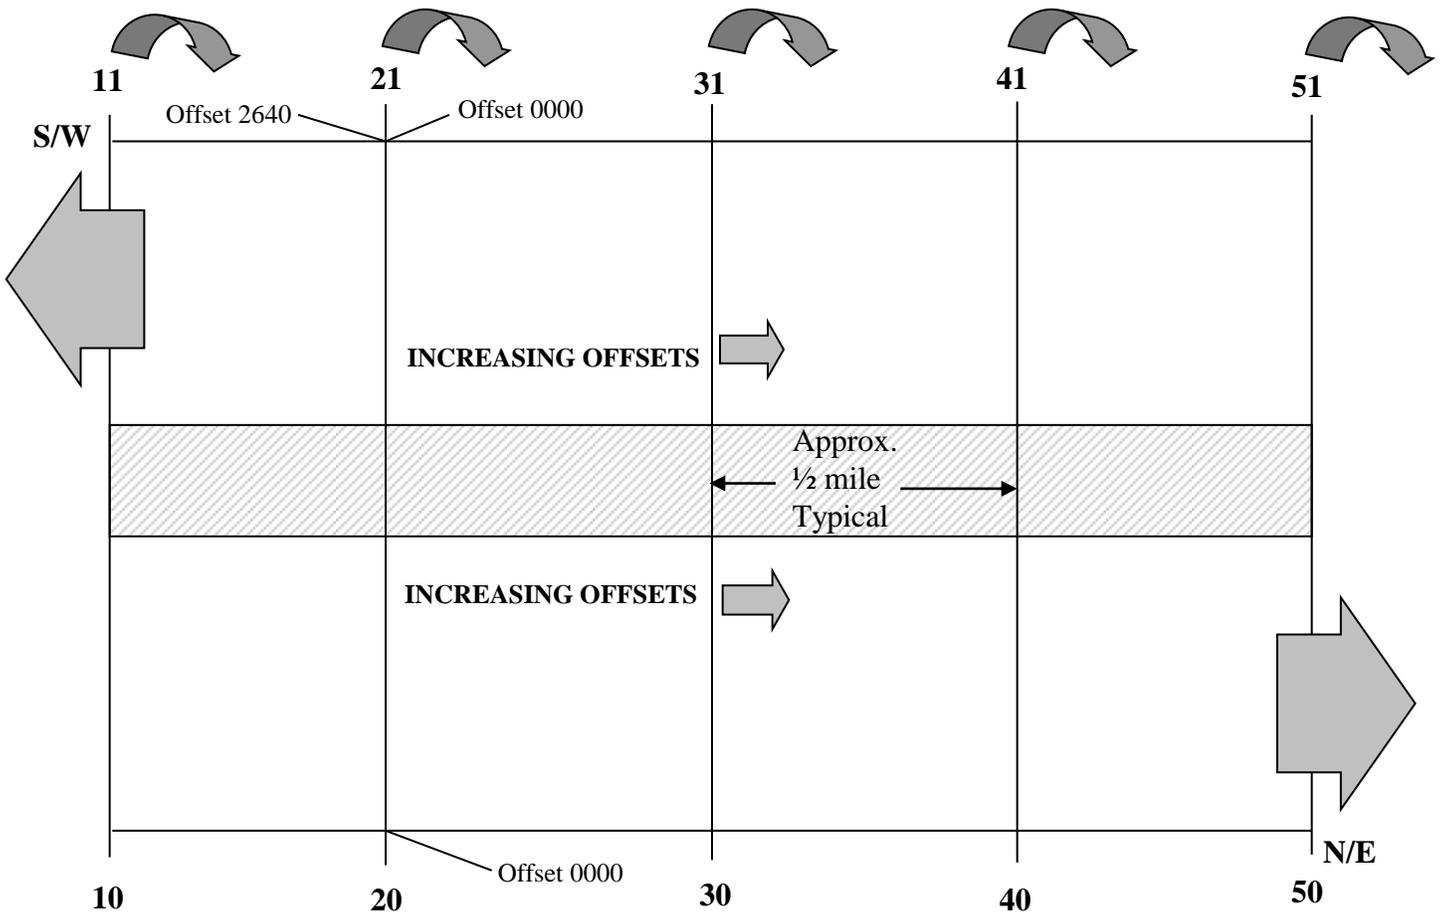
DIRECTIONAL SEGMENTING ON DIVIDED HIGHWAYS

- A. Segment = approximately one-half mile sections of SR's that are usually numbered by 10's.
- B. The beginning and ending points of Segments are placed at physical features where possible.
- C. Direction
 - Divided roads have directional segments
 - North or East are even numbers
 - South or West are odd numbers

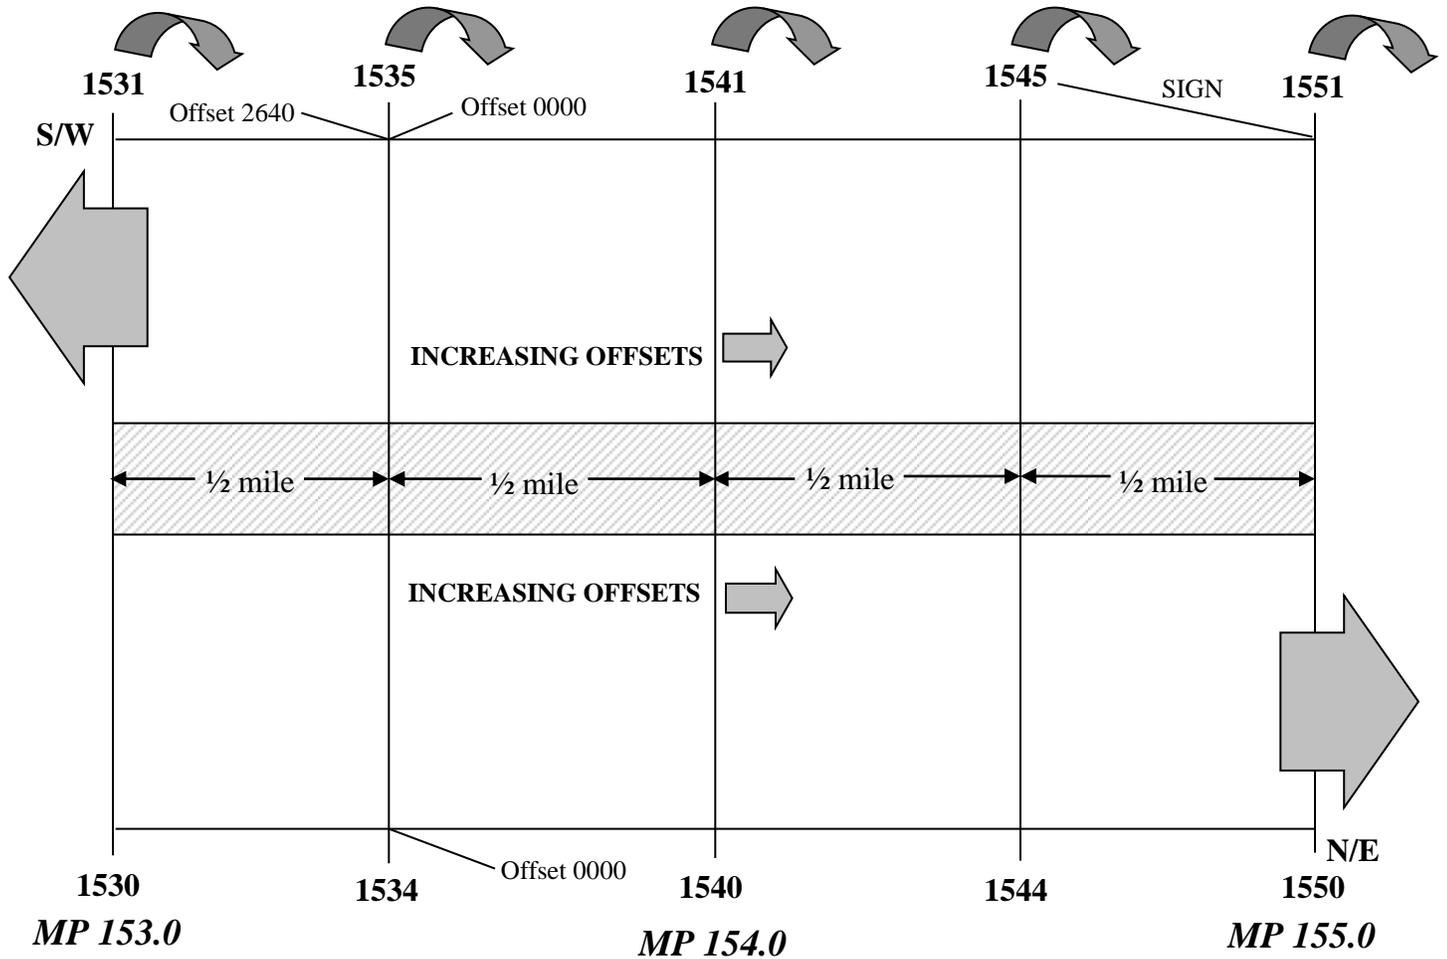
SEGMENTING ON INTERSTATE HIGHWAYS

- Interstate Segmenting is associated with the milepost.

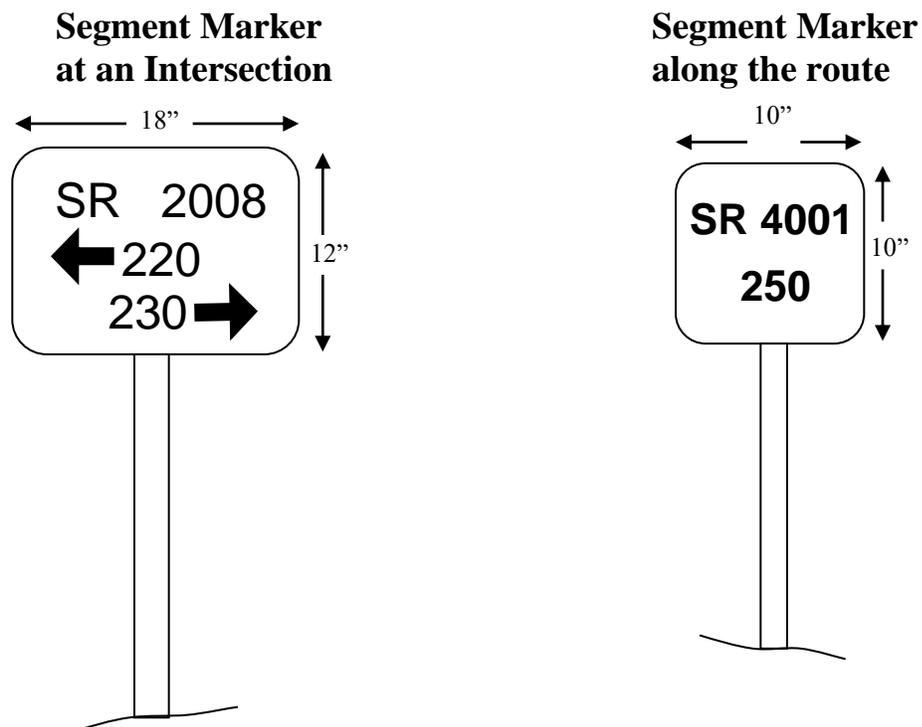
- Identifiable in field, easy for identification of maintenance/work areas on the State Highway System.
1. Segment Marker - indicates SR and segment number at the beginning and end of each segment. If the beginning or end of a segment occurs at a physical feature, then the point of reference is at the physical feature and NOT the sign.
 2. Intersection - indicates segmentation at the intersection of 2 or more state owned highways.

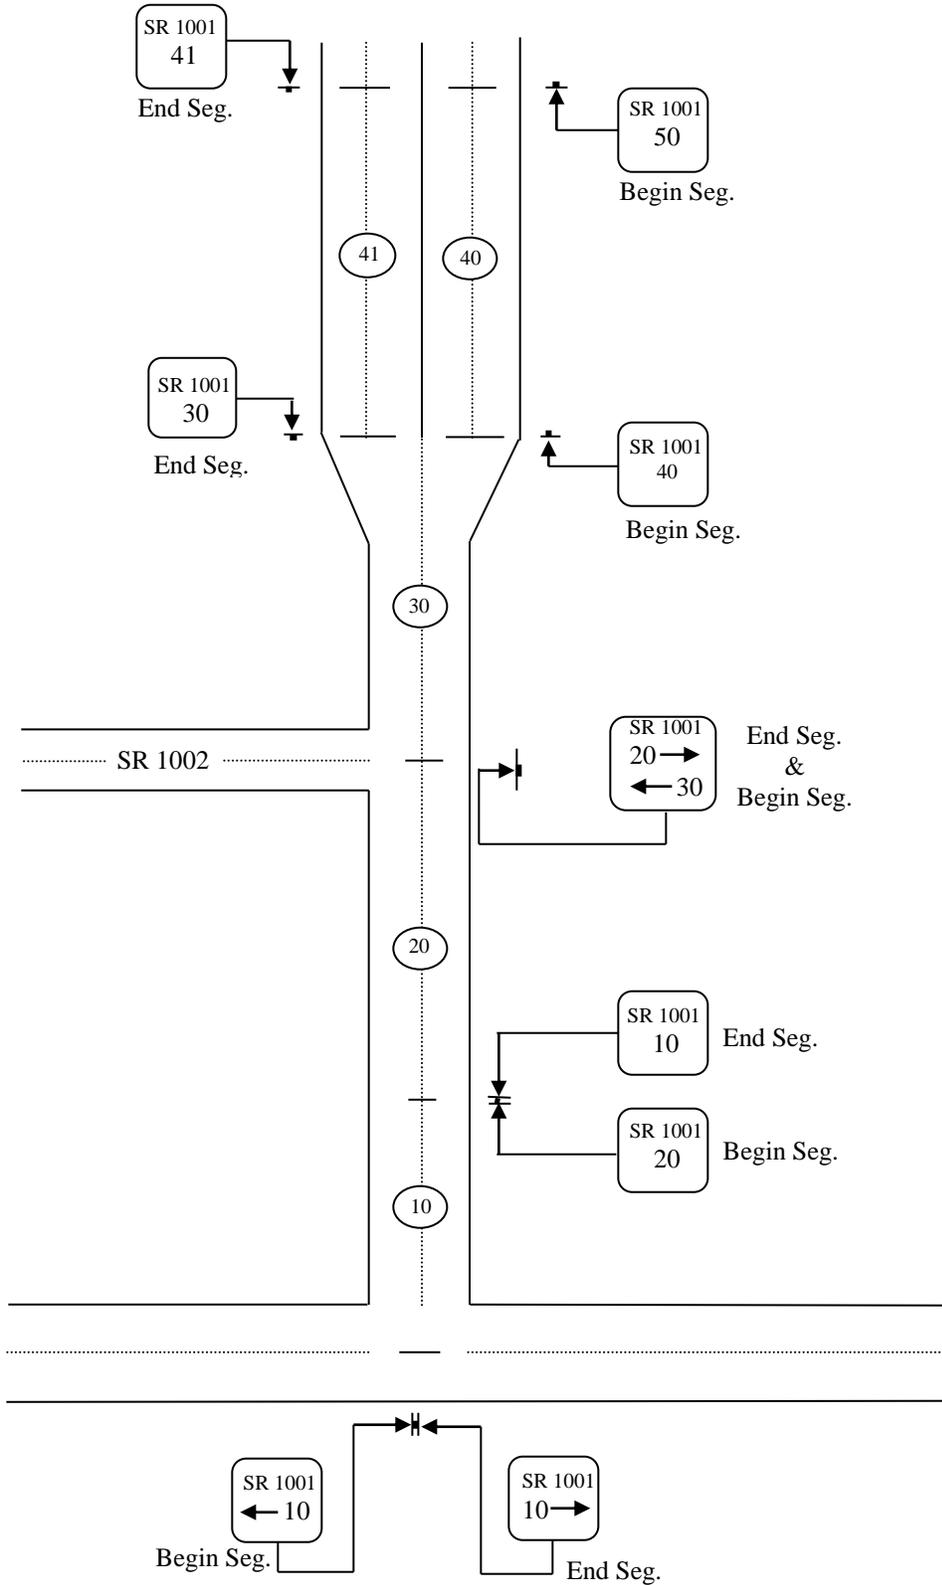
SAMPLE STATE ROUTE SIGNING

3. SR/Segment Sign Placement

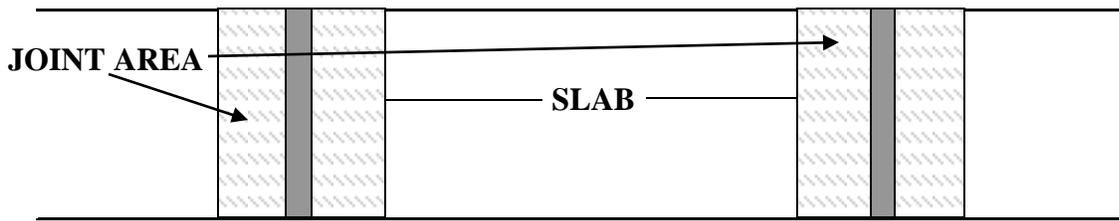
Joint area for evaluation: The procedure for identifying joint conditions is: Identify the joint. Evaluate the pavement for the full lane width on either side of the joint for 1.0 ft each side of the joint. Assign the joint condition to the appropriate classification and severity rating. Collect and report all distress on a joint (the distresses are cumulative).

Slab Conditions: Slab interior from 1.0 ft of joint area as defined above to the next 1.0 ft area of the next joint. Collect and report all distress on a slab (the distresses are cumulative) with the exception of Broken Slab. Rating a slab as Broken supersedes all other slab distresses.

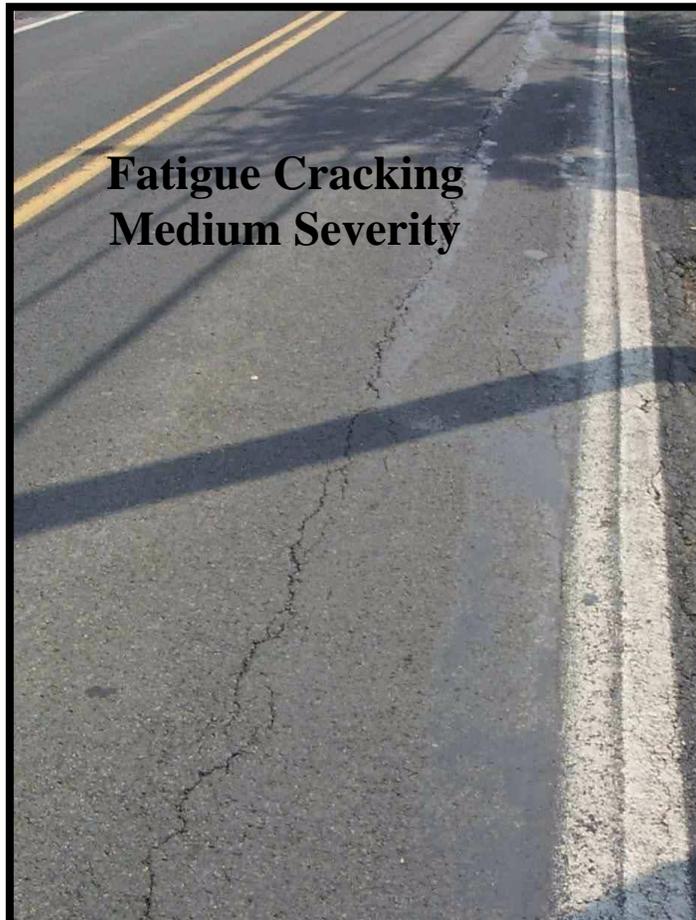
**Fatigue Cracking
Medium Severity**

- Medium:** Average Crack Width $>$ hairline and ≤ 0.25 in
Fatigue cracking consisting of longitudinal and interconnecting cracks typically forming a diamond shaped, chicken wire or alligator's hide pattern. The crack width ranges from fine, just over hairline cracking to widths that allow water to penetrate the surface as well as loss of some material from the surface or spalling.

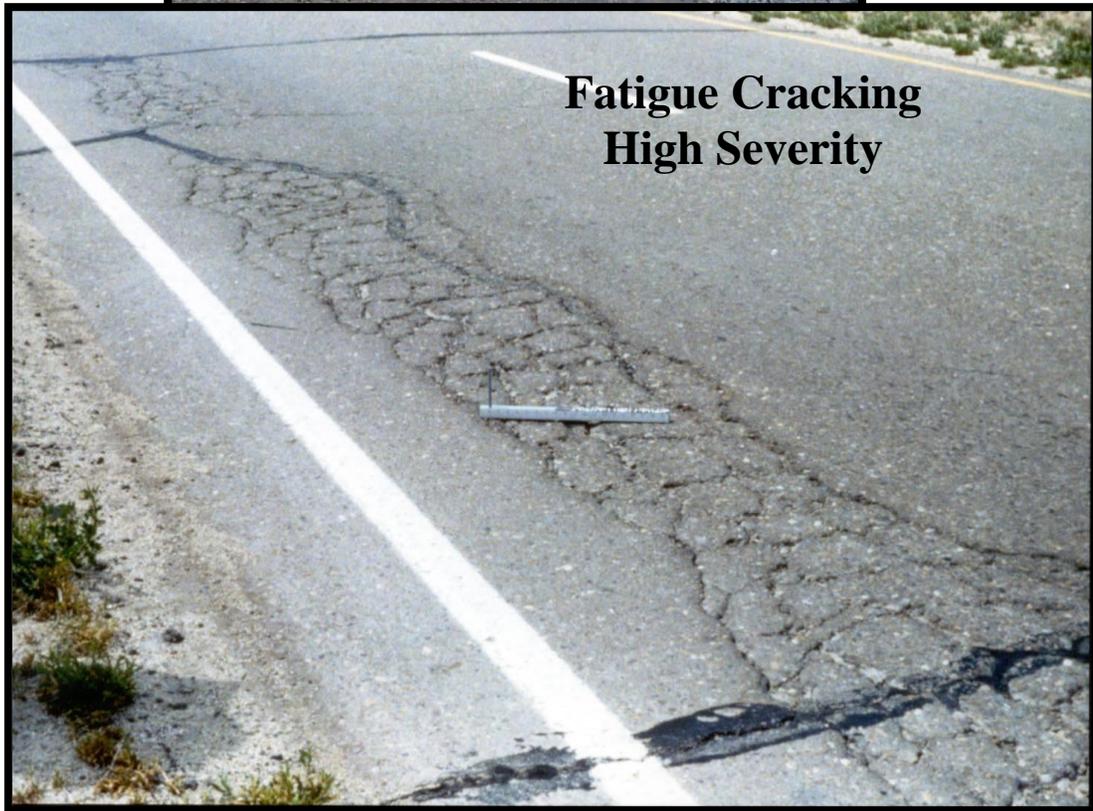
**Fatigue Cracking
High Severity**

- High:** Average Crack Width > 0.25 in
Fatigue cracking consisting of longitudinal and interconnecting cracks typically forming a diamond shaped, chicken wire or alligator's hide pattern. The cracks are sufficiently wide to allow water to enter the pavement surface. The width measurement includes loss of surface material or crack spalling.

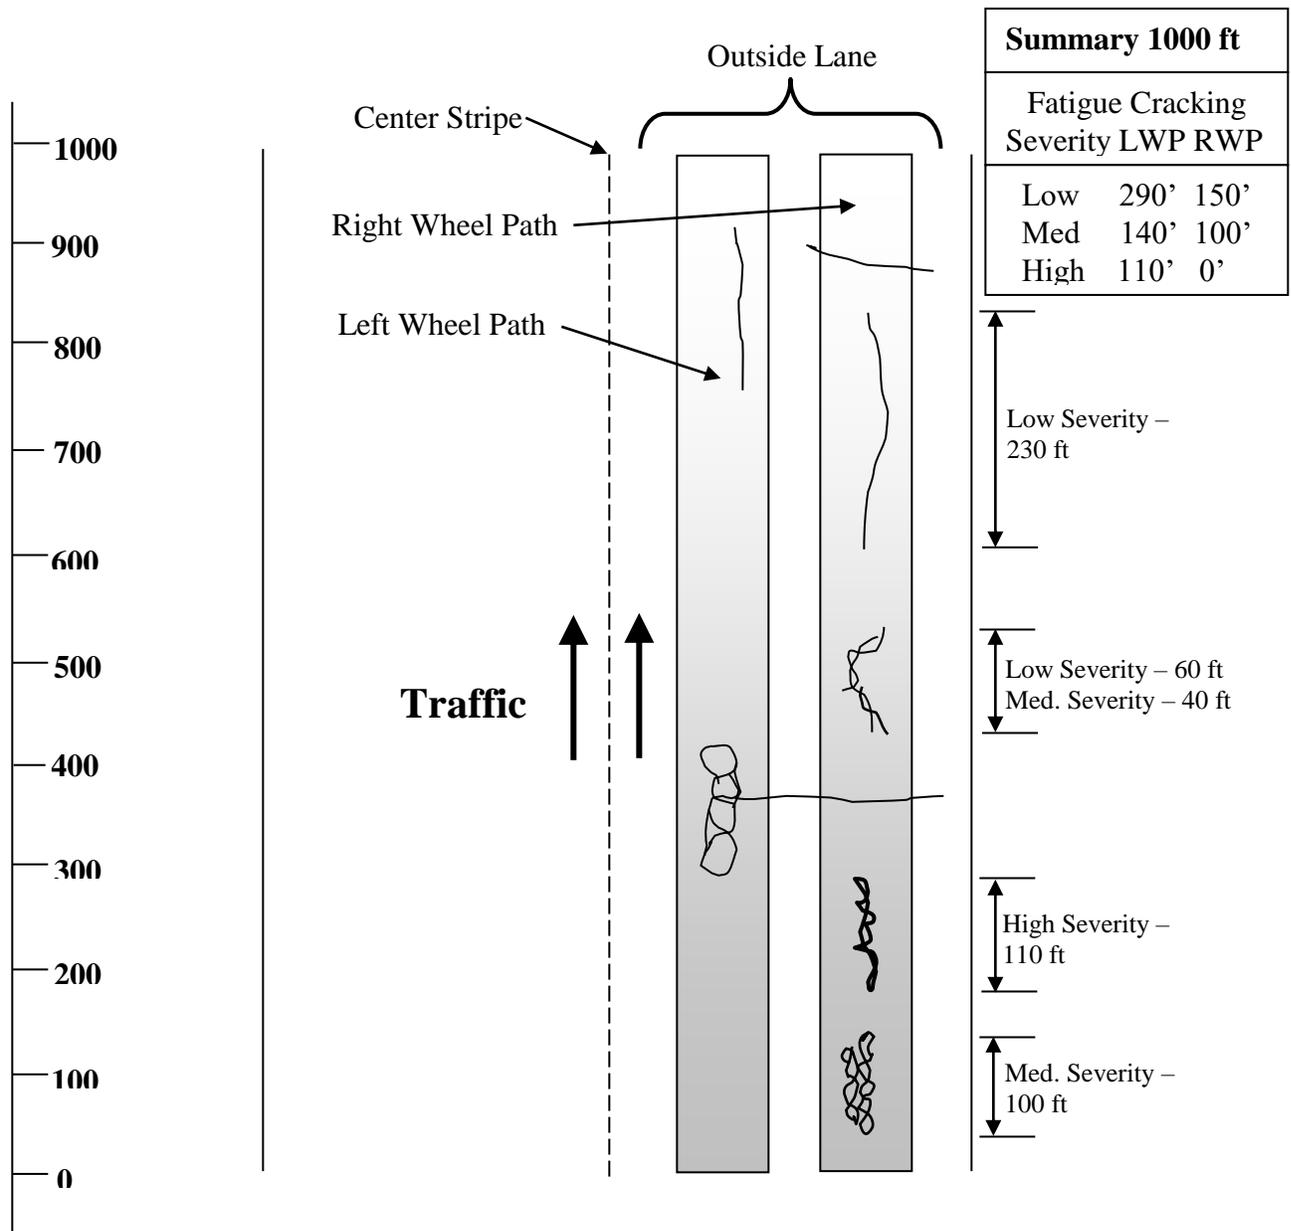
Fatigue Cracking Example

On a 1000-foot STAMPP segment, in the right wheel path (RWP), there are 2 occurrences of low severity fatigue cracking of 230 and 60 feet, there are 2 occurrences of medium severity fatigue cracking of 40 and 100 feet and 1 occurrence of high severity fatigue cracking of 110 feet. In the left wheel path (LWP) there is 1 occurrence of low severity fatigue cracking (150') and 1 occurrence of medium severity fatigue cracking (100'). The rating for the STAMPP segment would be: LWP - 290 ft low severity fatigue cracking, 140 ft medium severity fatigue cracking, and 110 ft high severity fatigue cracking. RWP – 150' low severity and 100' medium severity fatigue cracking.

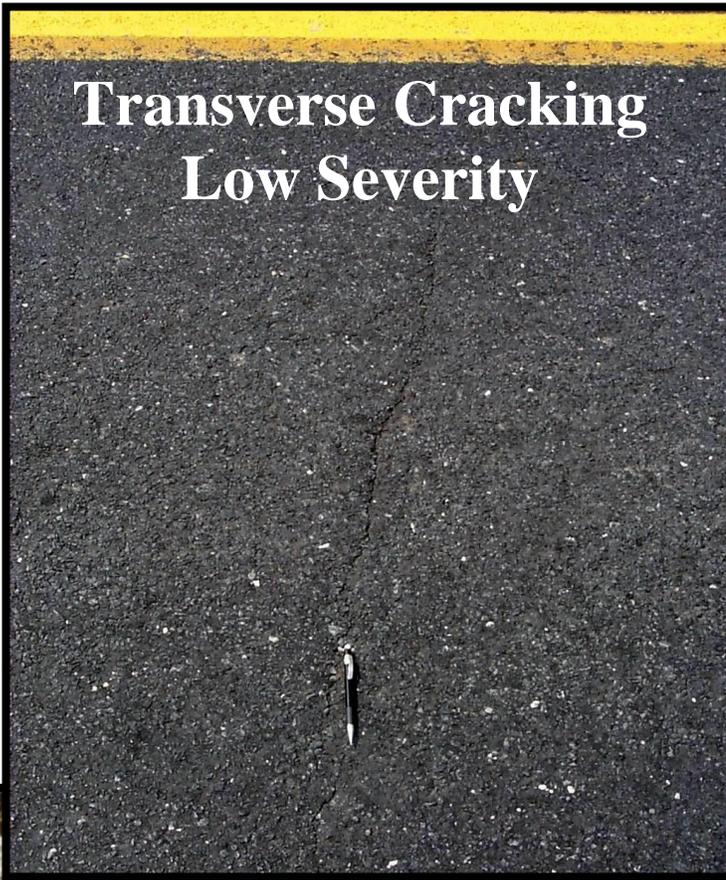
**Transverse Cracking
Low Severity**

Low: Average Crack Width $>$ hairline and ≤ 0.25 in

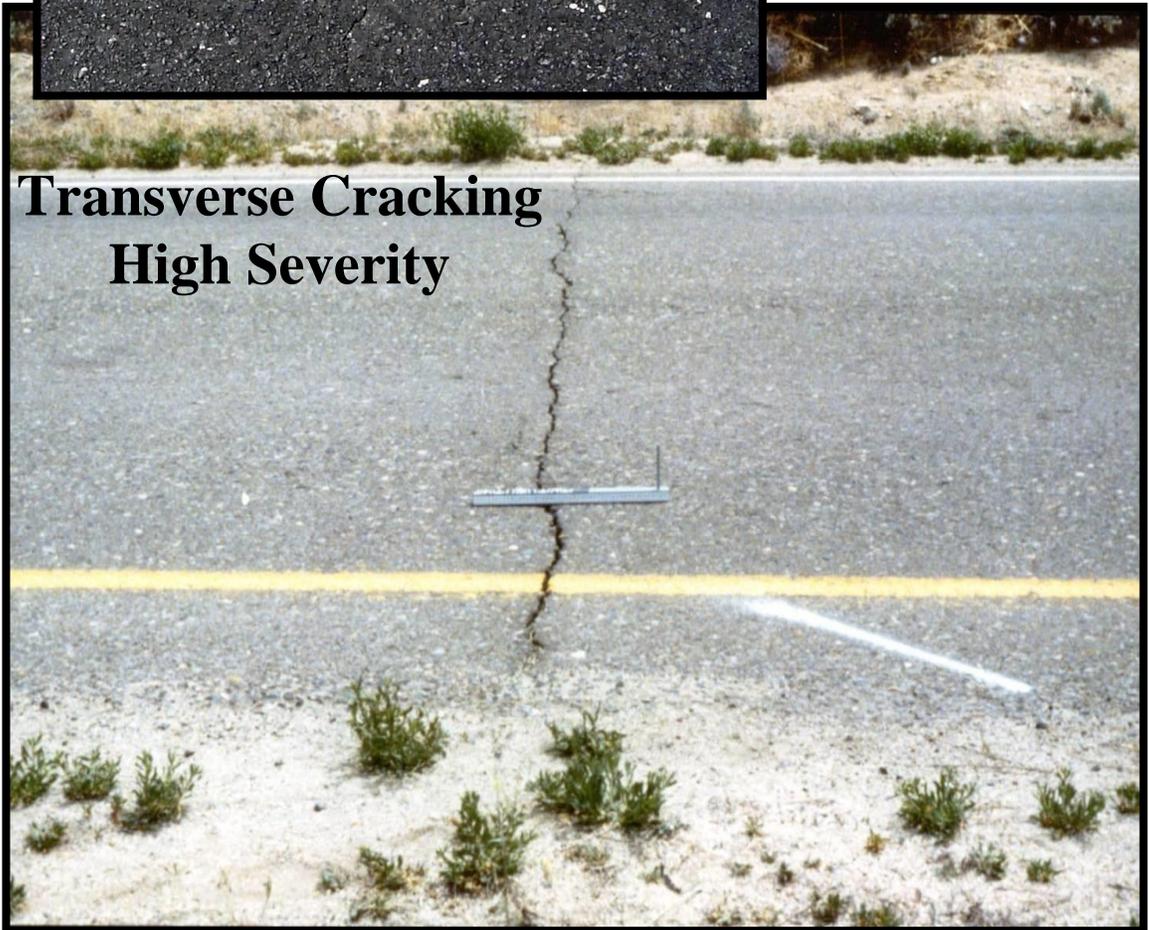
**Transverse Cracking
High Severity**

High: Average Crack Width > 0.5 in

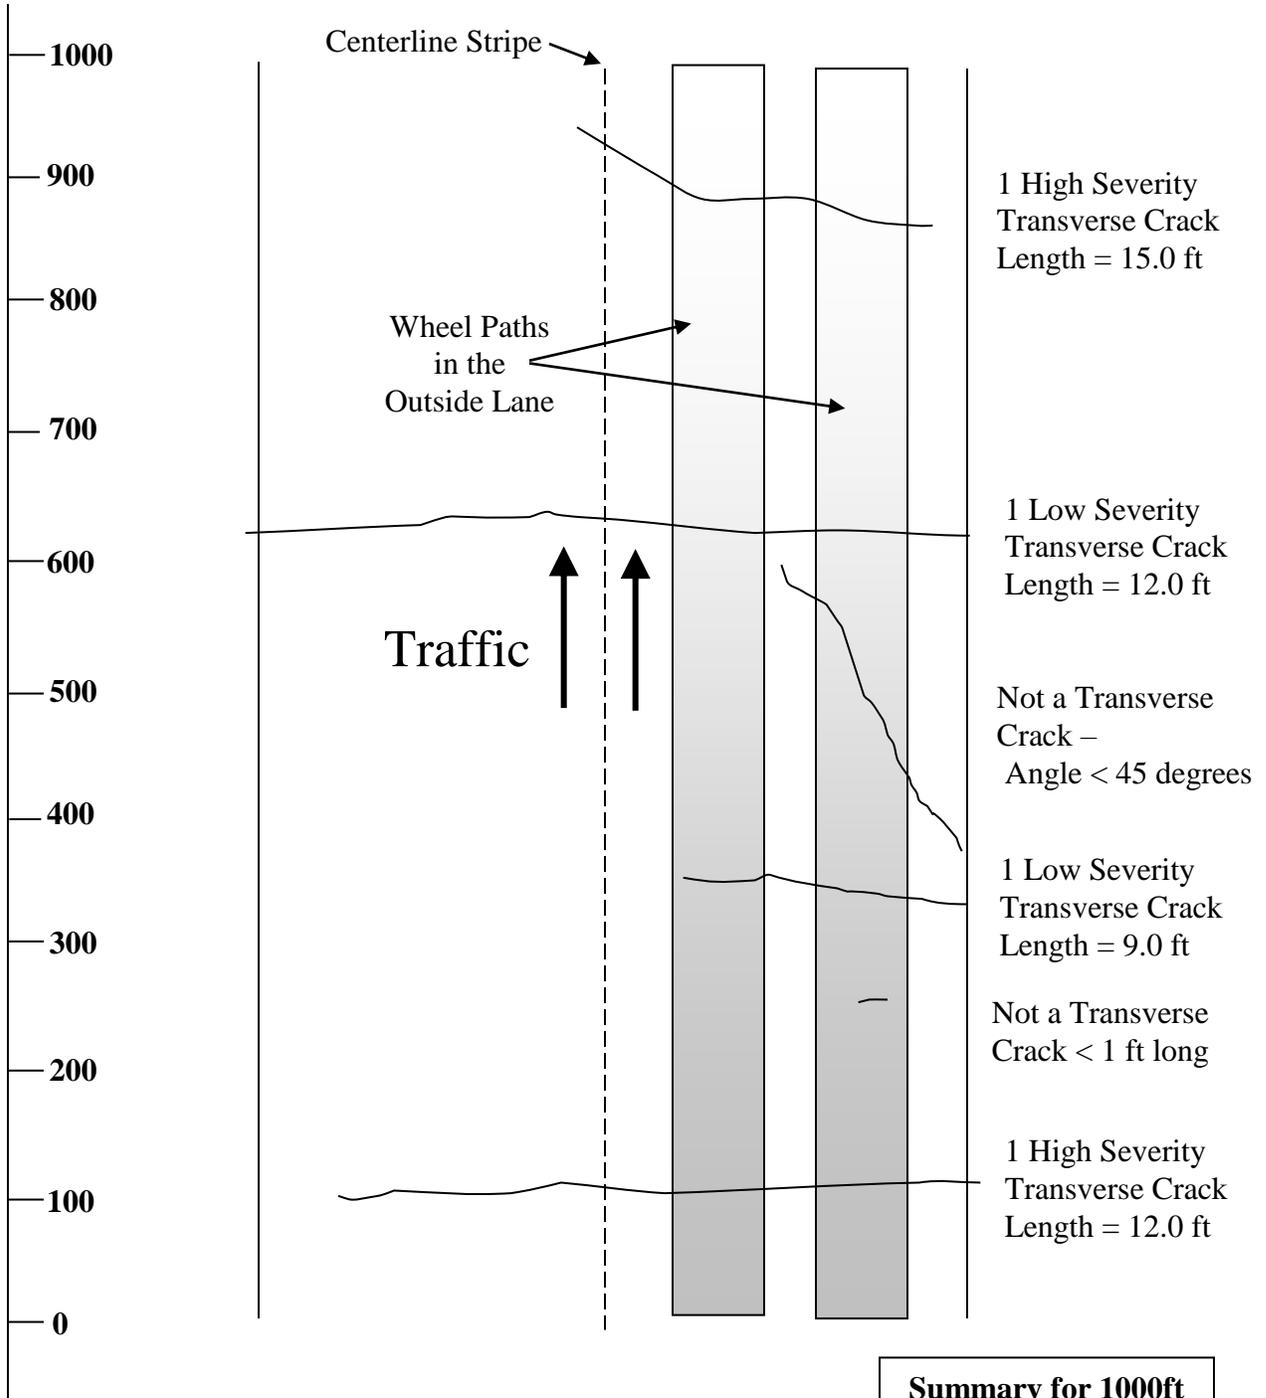
Transverse Cracking Example

A 1000-foot STAMPP segment has four Transverse Cracks that are identified to be rated. Two of the cracks are low severity and two are high. The total length of the two low severity cracks is 21 feet. The total length of the high severity cracks is 27 feet.

Summary for 1000ft		
Transverse Cracking Severity	Num.	Len.
Low	2	21
Medium	0	0
High	2	27

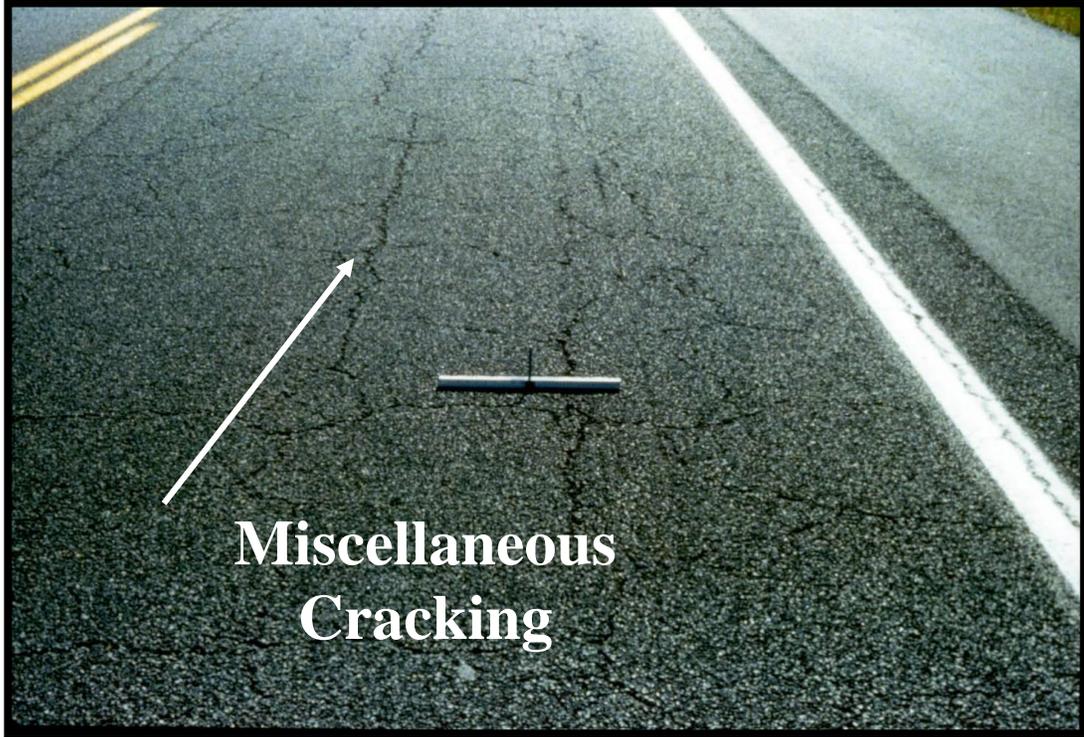
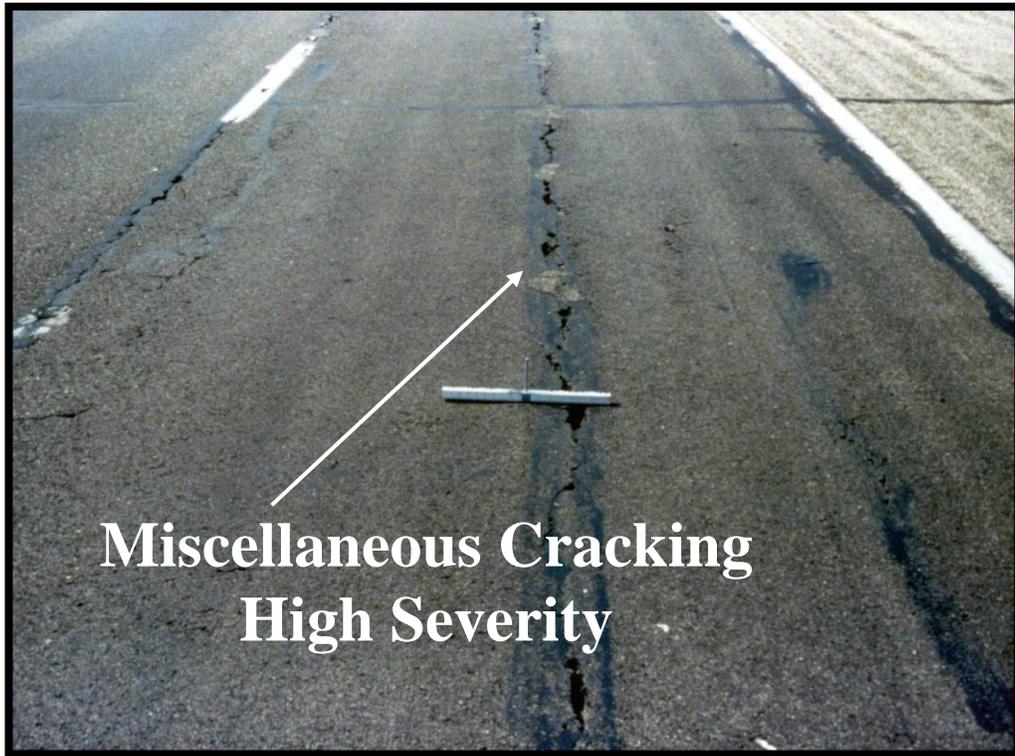
A 1000-foot STAMPP segment has two locations where miscellaneous cracking occurs. The first is longitudinal cracking in the lane center. This location is evaluated for the severity and length of miscellaneous cracking. The second is an occurrence of block cracking. This location is evaluated for transverse cracking first. Once the number and length of transverse cracks are recorded,

the length of the miscellaneous cracking is evaluated. In the example that follows: the section has 100 feet of low severity miscellaneous cracking, 420 feet of medium severity miscellaneous cracking and 190 feet of high severity miscellaneous cracking.

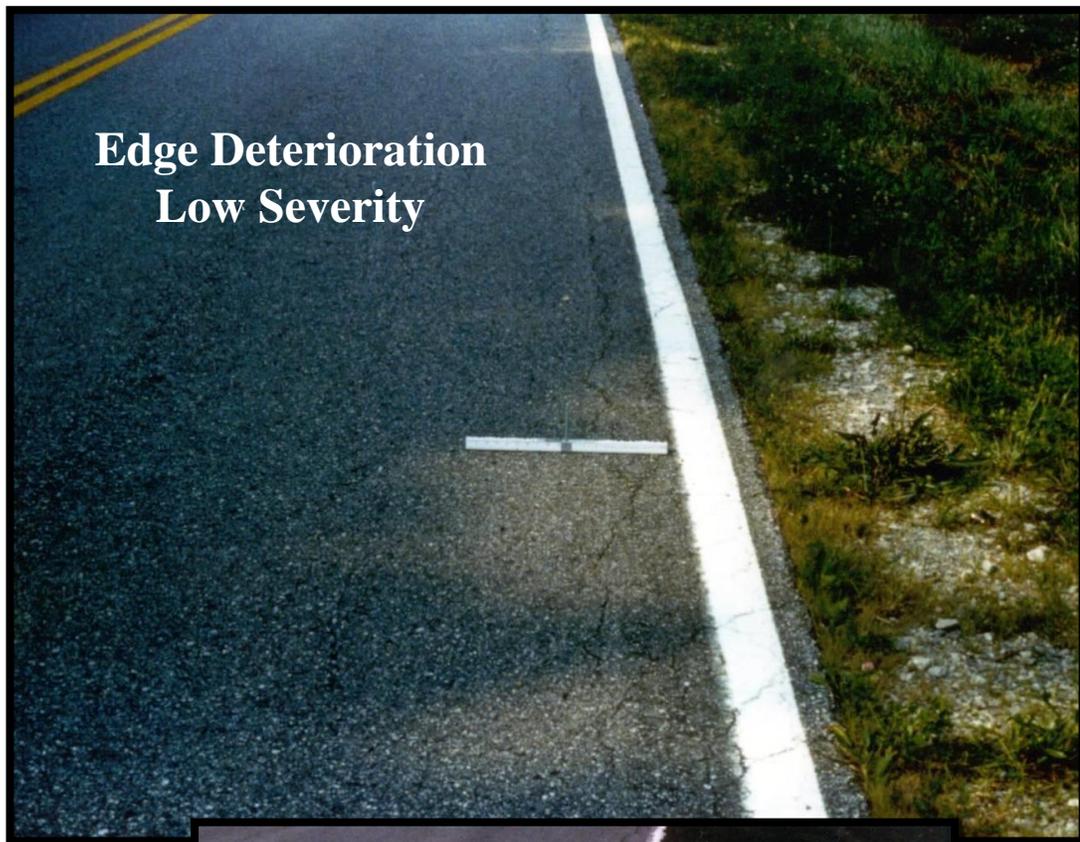
A 1000-foot STAMPP segment has 2 occurrences of low severity edge deterioration of 280 and 50 feet, 2 occurrences of medium severity edge deterioration of 50 and 90 feet and 1 occurrence of high severity edge deterioration of 90 feet. The rating for this STAMPP segment is: 330 ft low severity edge deterioration, 140 ft medium severity edge deterioration and 90 ft high severity edge deterioration.

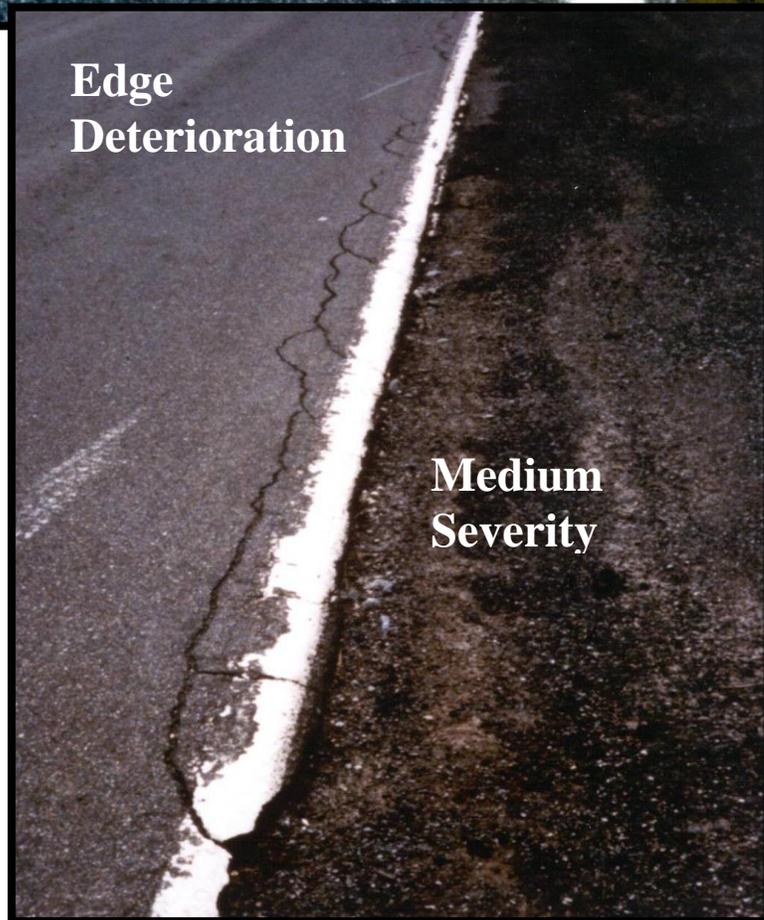
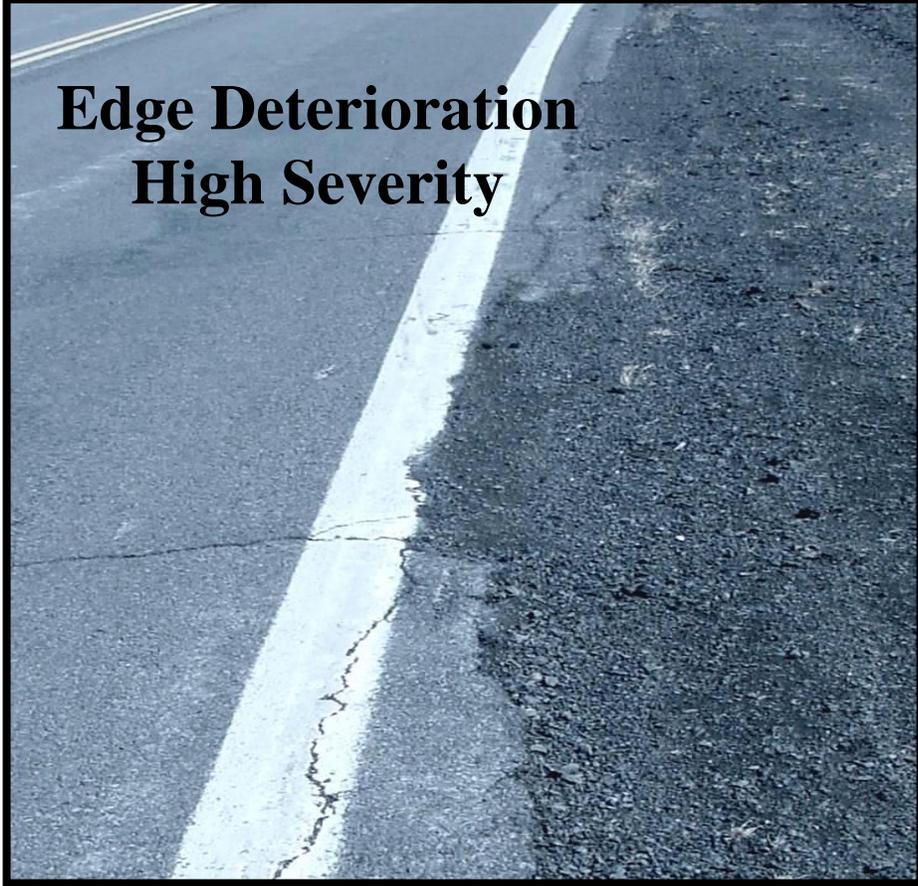
**Edge Deterioration
High Severity**

- Low: Average Crack Width > hairline and ≤ 0.25 in
The width measurement may include crack spalling. No loss of pavement material is allowed in this category.
- Medium: Average Crack Width > 0.25 in and ≤ 0.50 in. The edge of the pavement is becoming jagged.
- High: Average Crack Width > 0.50 in. The edge of the pavement is deteriorated and pieces of the pavement edge are broken loose or missing.

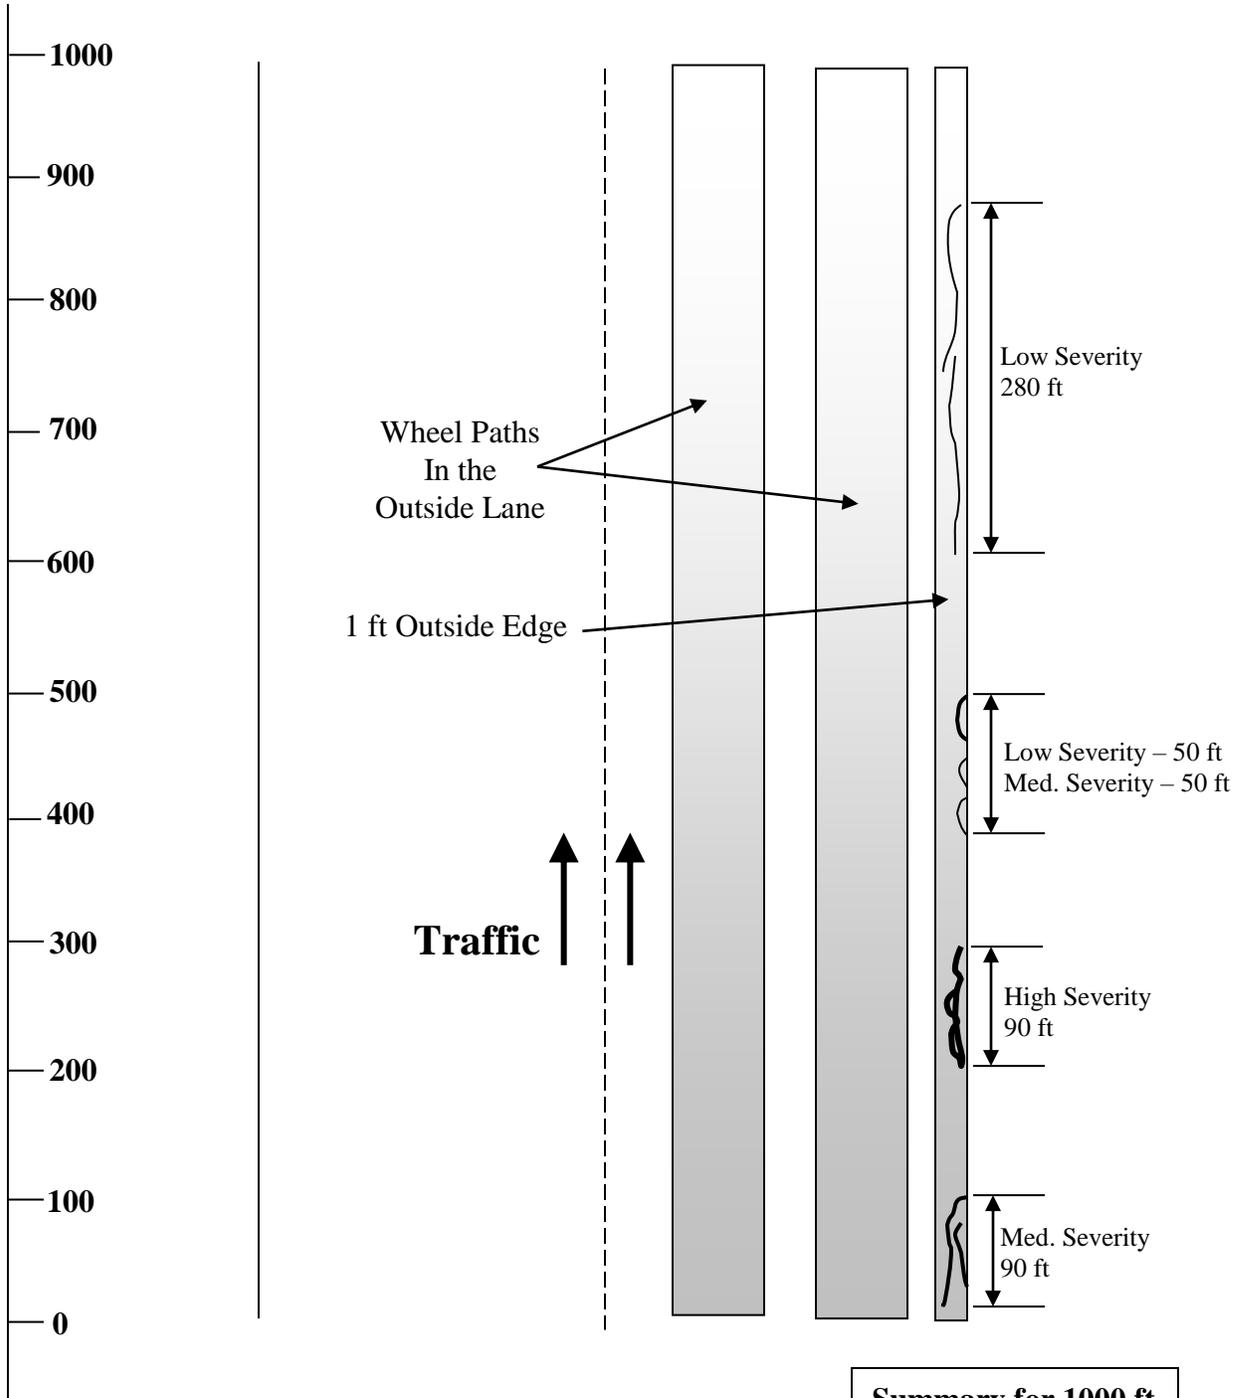
Edge Deterioration Example

Summary for 1000 ft	
Edge Deterioration Severity	Length
Low	330
Medium	140
High	90

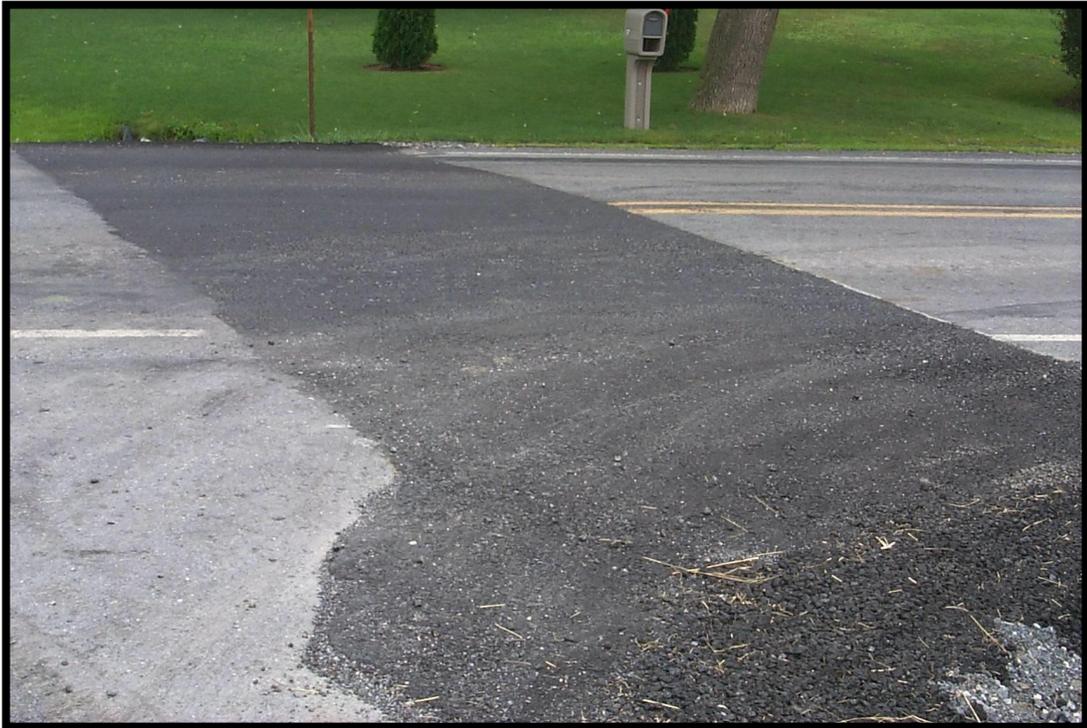
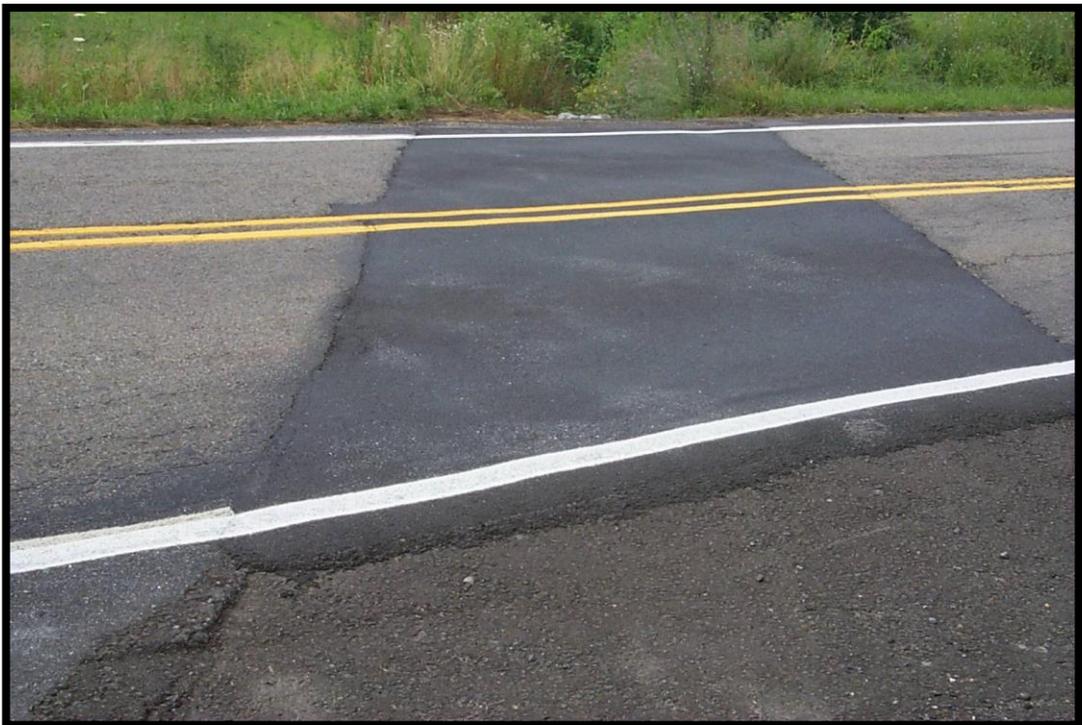
Bituminous Patching

This condition is characterized by an area of the original asphalt pavement, which has been replaced by bituminous material. Patches are easily recognized because they will generally be darker than the surrounding pavement since they are newer. The patch must have a surface area of at least 1.0 sq ft to be counted. If a full-width patch is more than 400 ft long, do not rate as a patch - it is considered an overlay or surface seal.

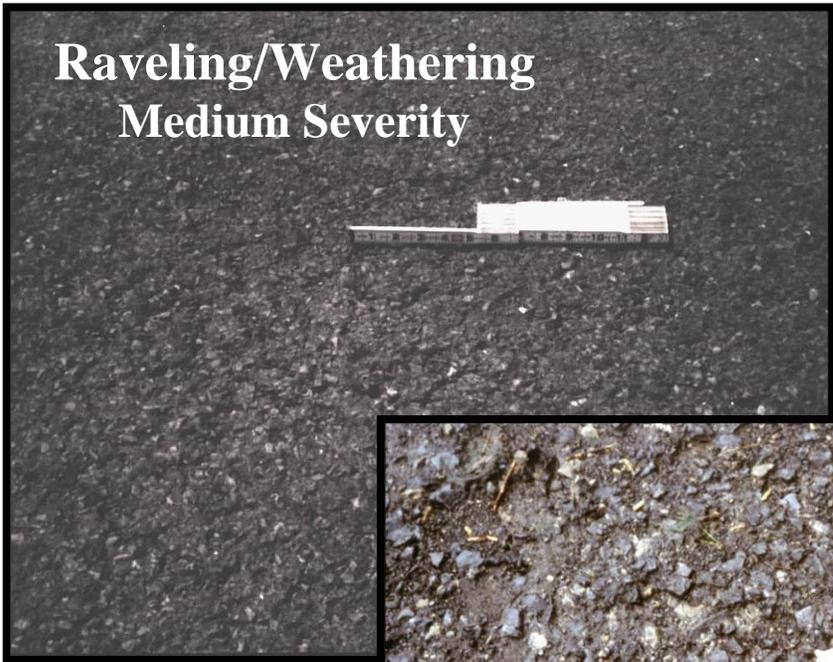
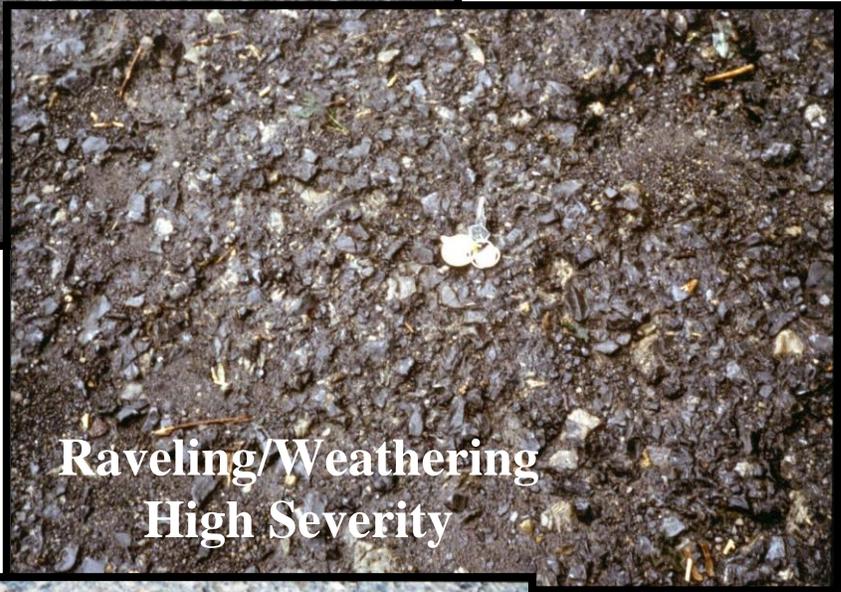
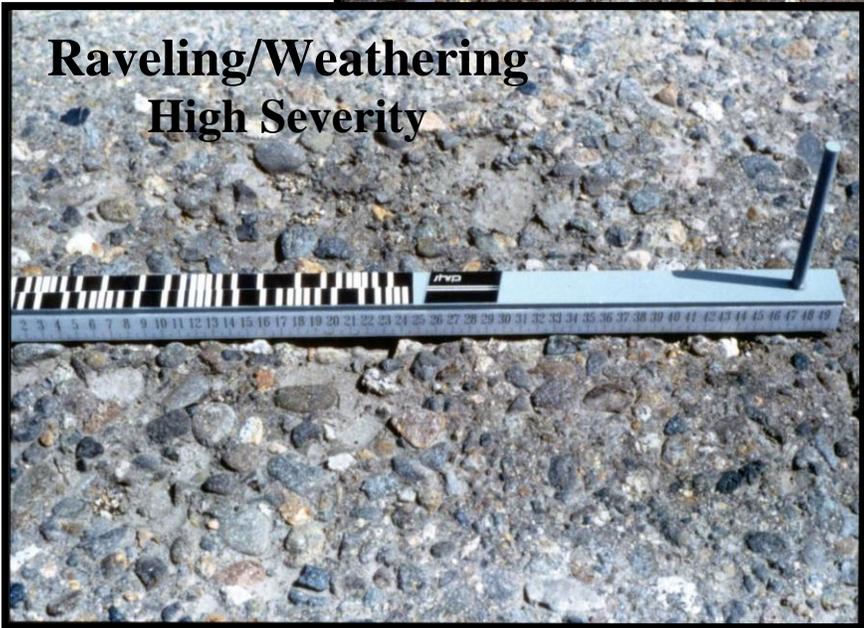
On a 1000-foot long, 9-foot wide STAMPP Segment there are two localized areas of raveling and weathering. The first contains a length of 125 feet of medium severity raveling and weathering. The second contains a length of 65 feet of high severity raveling and weathering. The rating for this section is: 125 feet medium severity raveling and weathering and 65 feet high severity raveling and weathering.
