**AUTOMATED PAVEMENT CONDITION SURVEY
FIELD MANUAL
PUBLICATION 336**

APRIL 2020

**PREPARED BY:
BUREAU OF MAINTENANCE AND OPERATIONS
ASSET MANAGEMENT DIVISION
P.O. Box 3437
HARRISBURG, PENNSYLVANIA 17105-3437
(717) 787-6899**

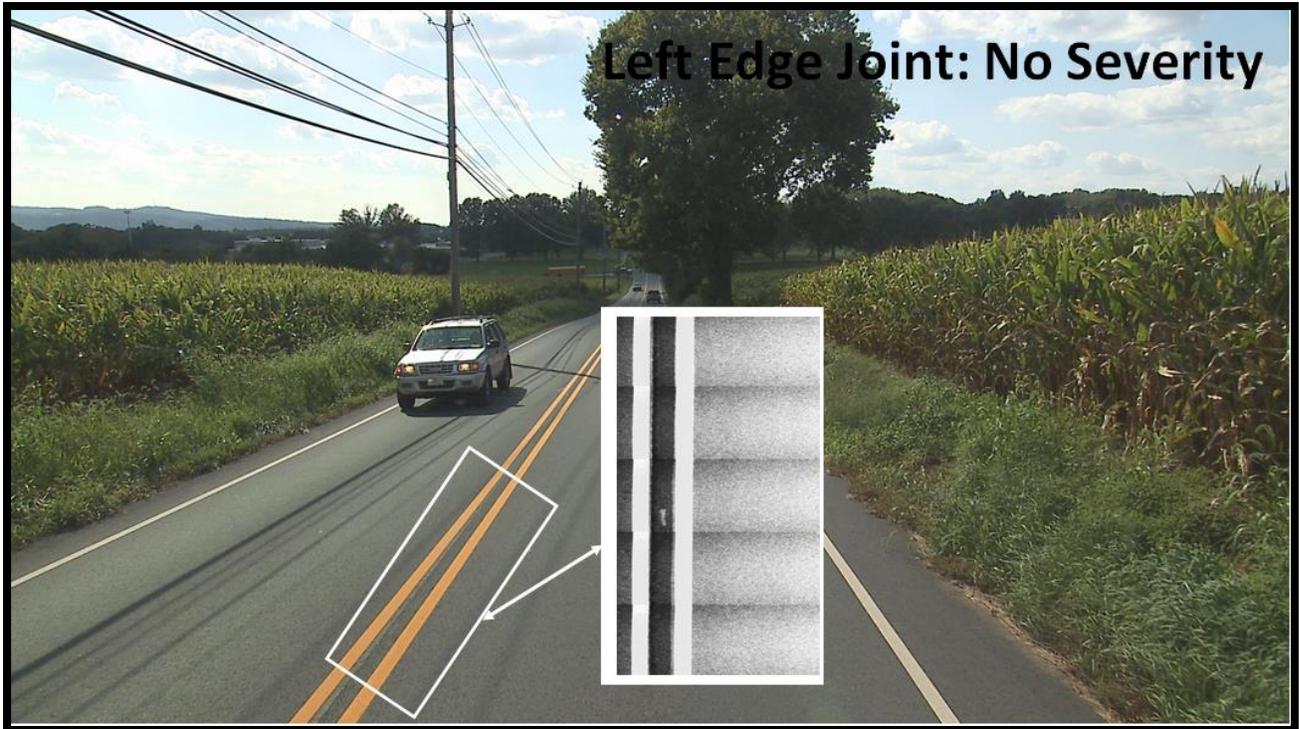
Left Edge Joint Examples

On a 2640-foot long, 12-foot wide STAMPP Segment there are two localized areas of left edge joint distress. The first contains a length of 1250 feet of low severity distress. The second contains a length of 650 feet of medium severity distress. The rating for this section is: 1250 feet low severity and 650 feet medium severity left edge joint distress.

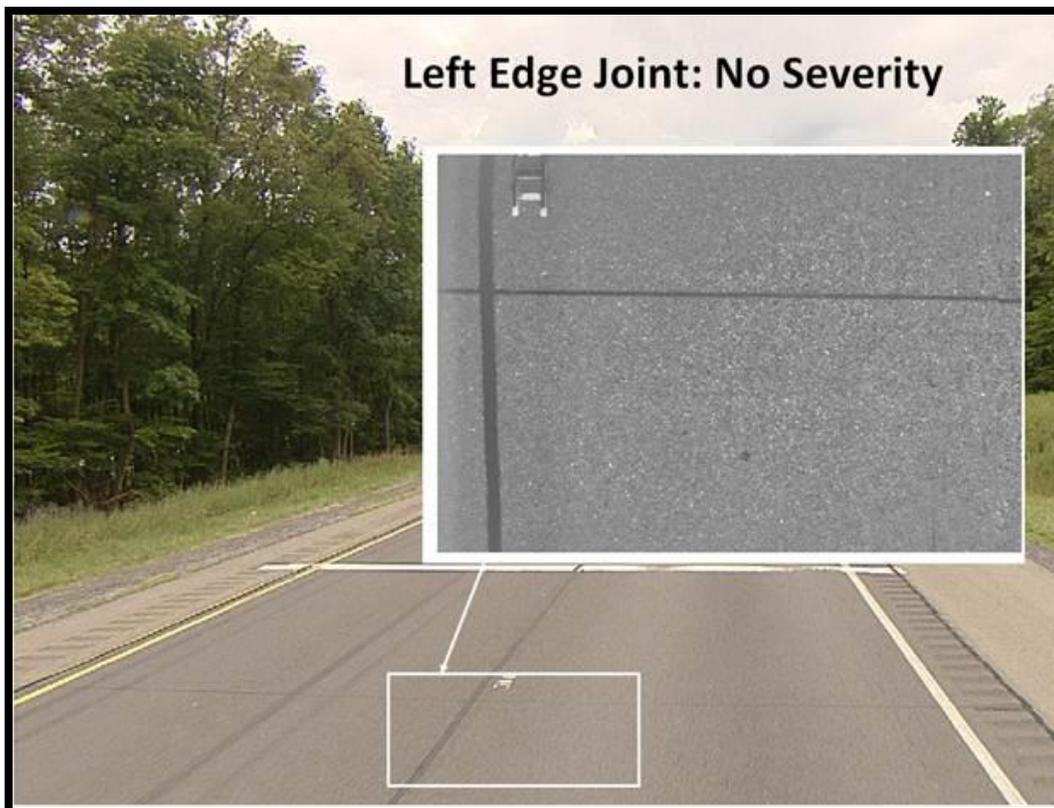
Left Edge Joint: Low Severity

- Low:
- Construction joint open $< \frac{1}{4}$ ".
 - If any cracks parallel to the joint are present, they are hairline width.
 - No loss of material in this category and no patching.
- Medium:
- Construction joint open $\frac{1}{4}$ " to $\frac{1}{2}$ ".
 - Random adjacent cracks are $\leq \frac{1}{4}$ " wide and interconnected forming jagged pieces.
 - Some minor loss of material (spalling) visible but no patching present.
- High:
- Construction joint open $> \frac{1}{2}$ ".
 - Random adjacent cracks are $> \frac{1}{4}$ " wide and interconnected forming jagged pieces.
 - Visibly severe loss or breaking of material (spalling) or patching of construction joint present.

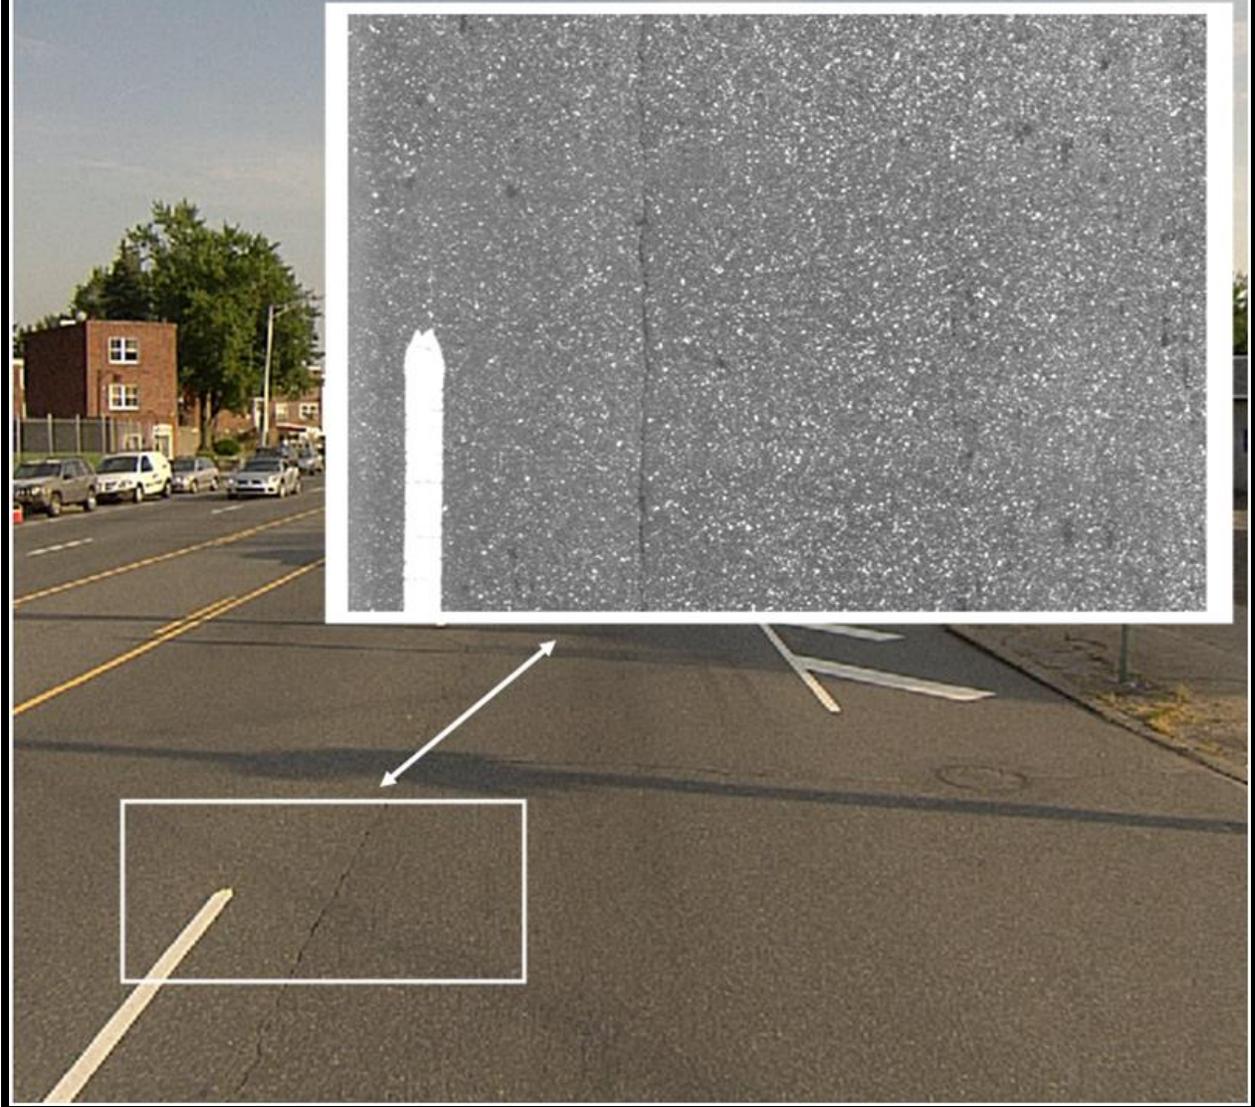
Note: Assume construction joint is within one foot of the white lane markings for the purpose of this example.

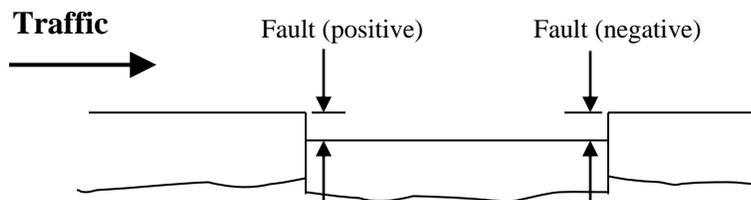
Faulted Joints Example

A 1000-foot STAMPP segment has 16 joints. Of these 16 joints, 3 are measured as medium severity and 5 as high severity. The rating for this section is: 8 joints none, 3 joints medium and 5 joints high severity faulting.

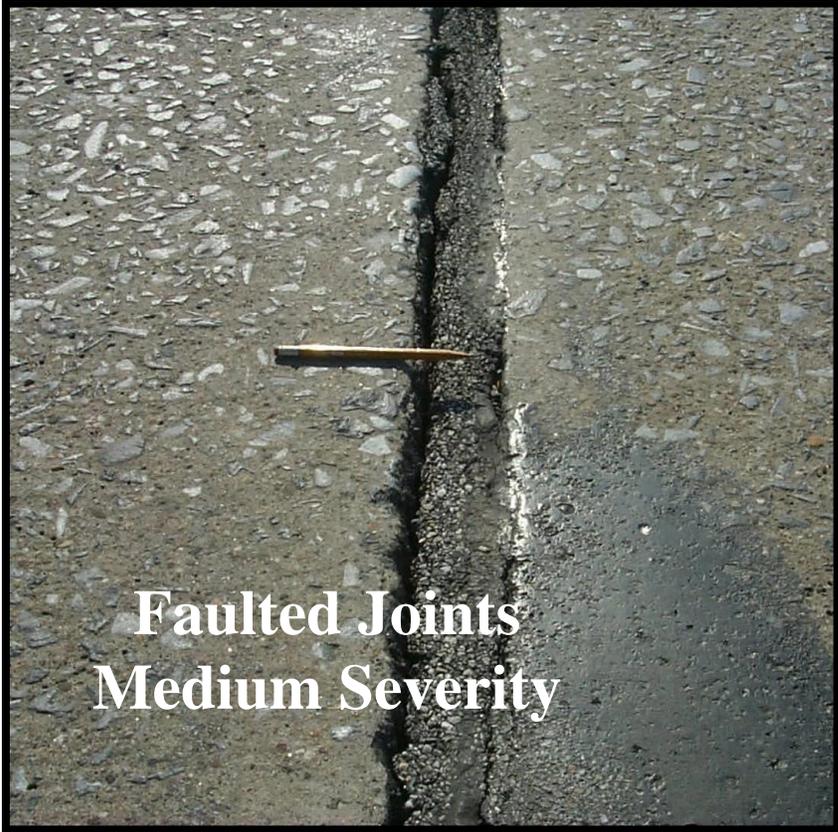
**Faulted Joints
Medium Severity**

This condition is characterized by a difference in elevation across a transverse joint.

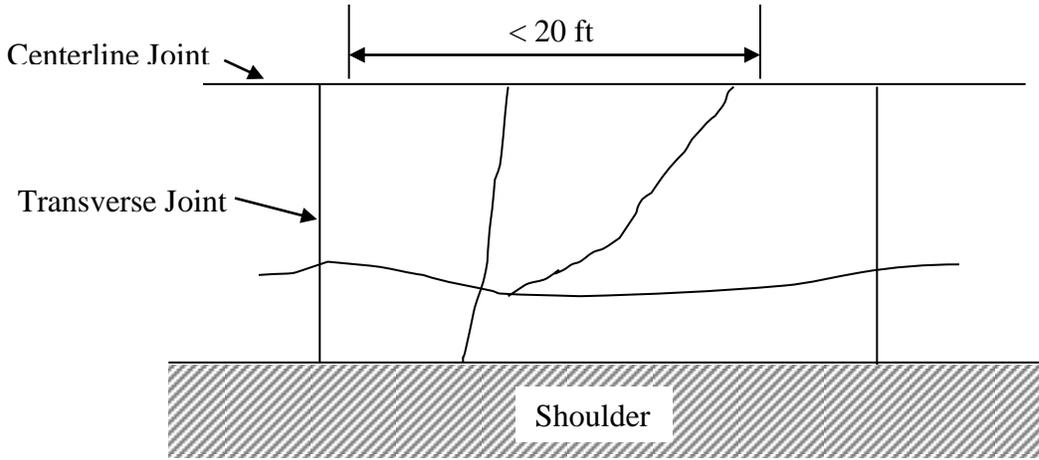
5 Sections in 20 ft

This condition is characterized by the cracking or breaking of the concrete slab into four or more pieces, within a 20-ft length of the slab, the pieces generally being greater than 1 sq ft in area.

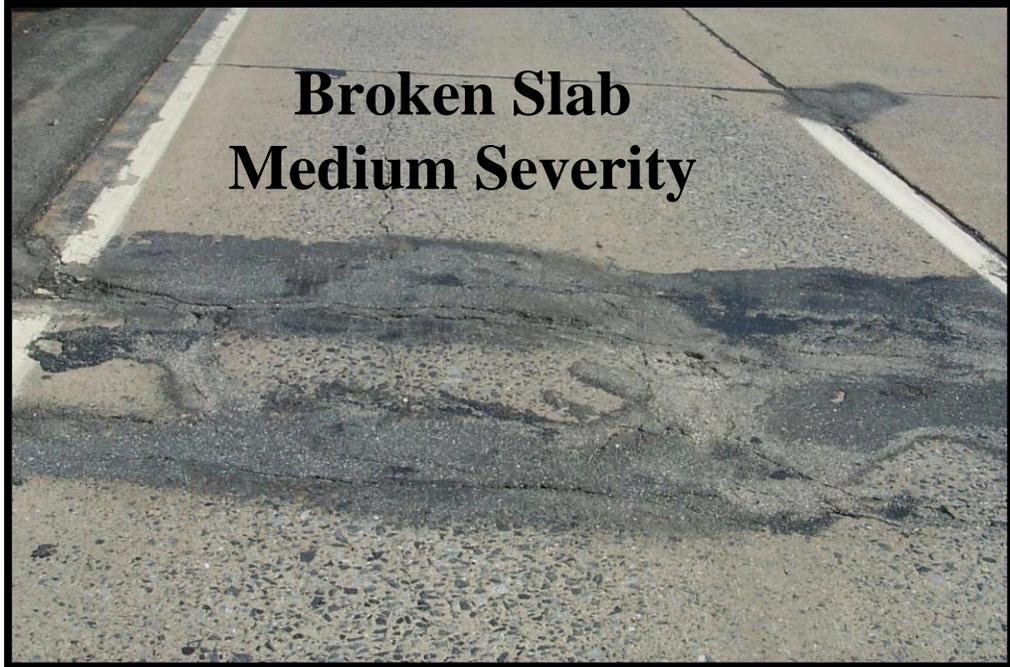
**Broken Slab
Medium Severity**

Medium: At least 4 pieces in a 20-foot length with an average crack width $>$ hairline and \leq 0.25 in, may have faulting $>$ 0.25 in and \leq 0.50 in OR IRI $>$ 100 and \leq 200 in/mi.

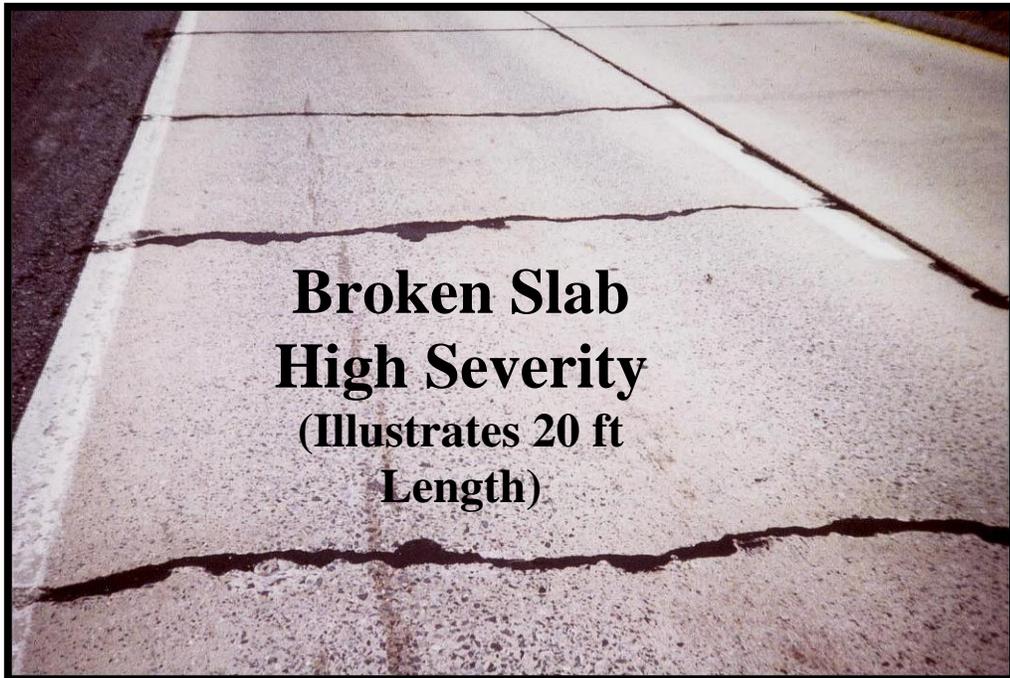
**Broken Slab
High Severity
(Illustrates 20 ft
Length)**

High: At least 4 pieces in a 20-foot length with an average crack width $>$ 0.25 in, may have faulting $>$ 0.5 in OR IRI $>$ 200 in/mi.

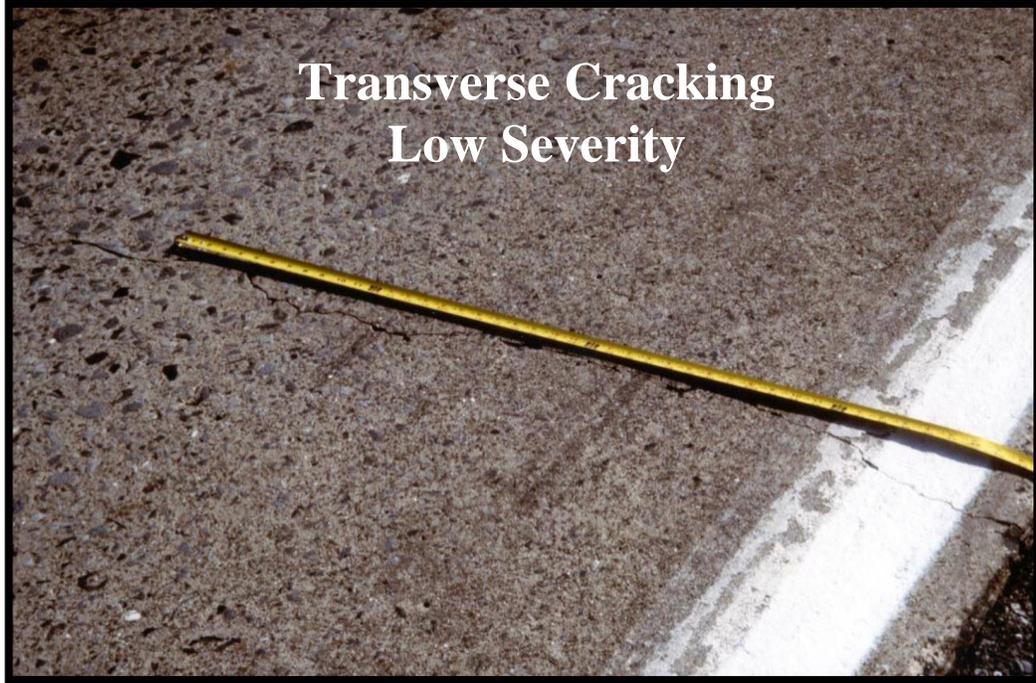
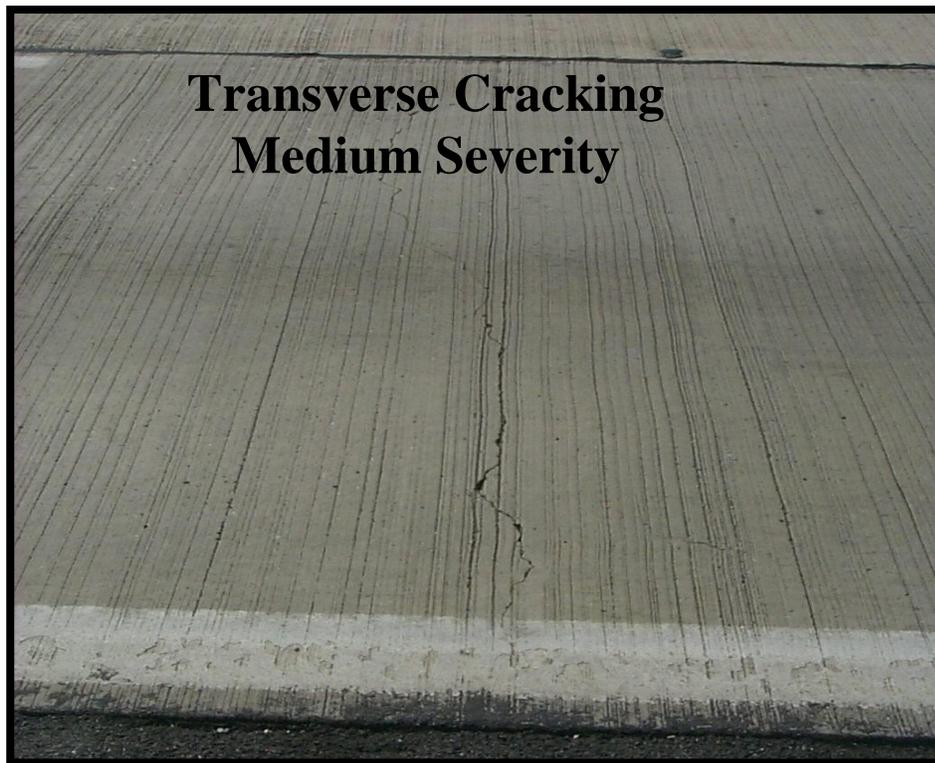
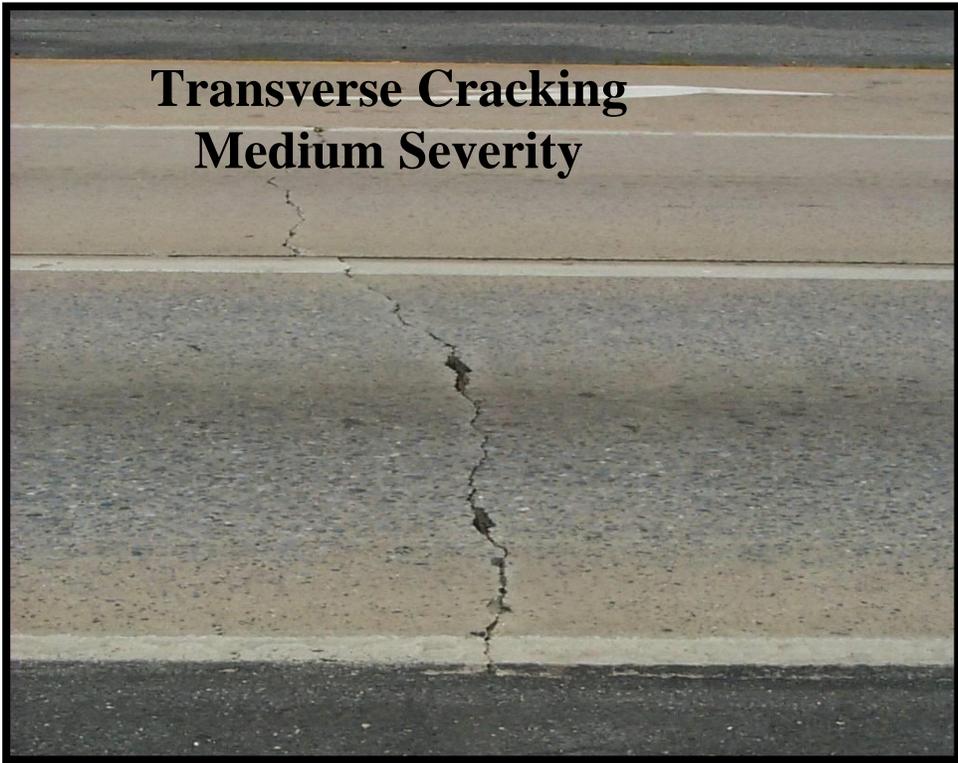
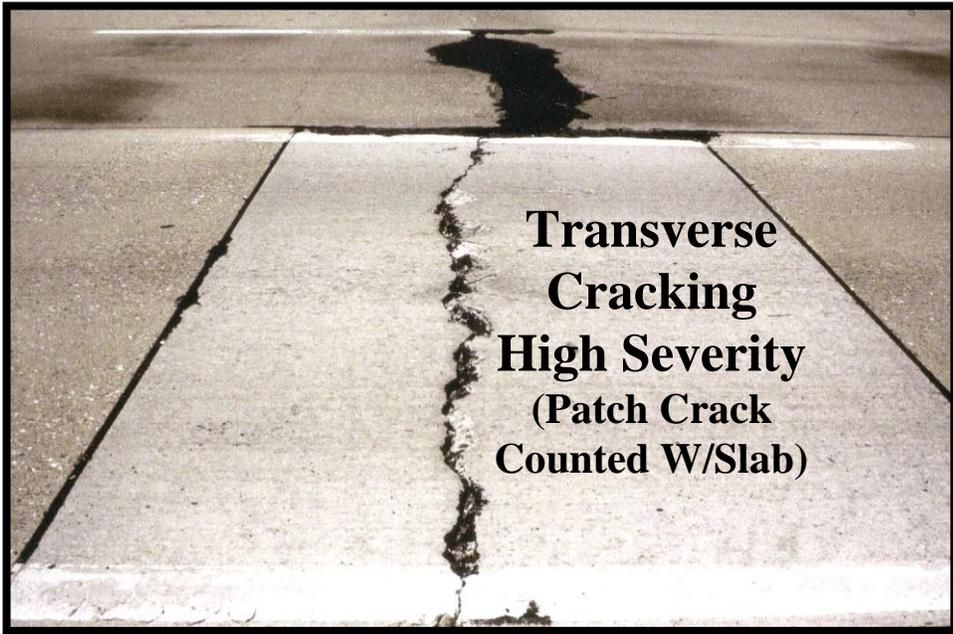
A 1000-foot STAMPP segment has 16 slabs with 2 slabs showing transverse cracking in the low severity category and 6 in the medium severity category. The rating for this segment is: 8 slabs none, 2 slabs low severity and 6 slabs medium severity transverse cracking.

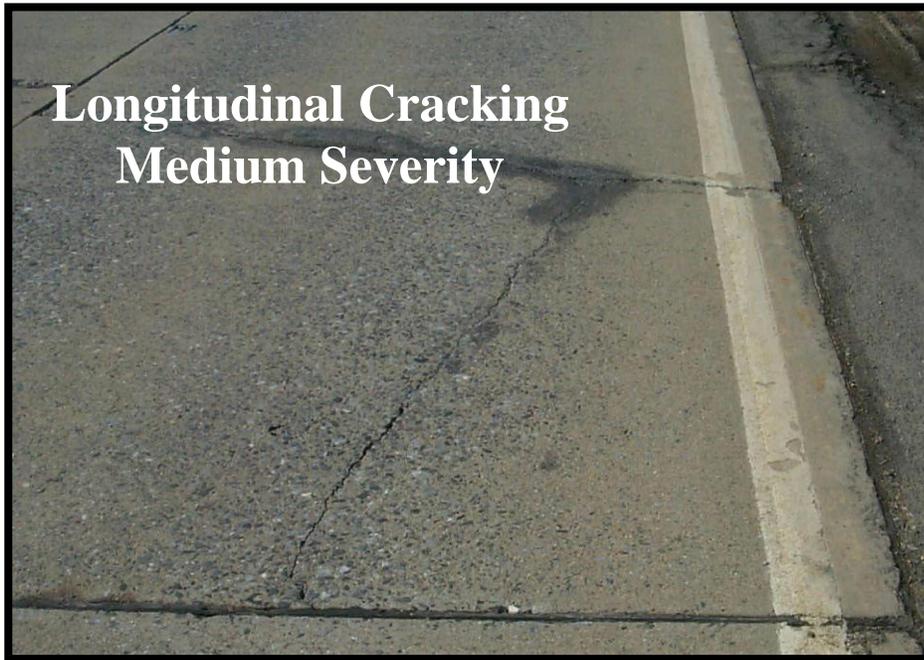
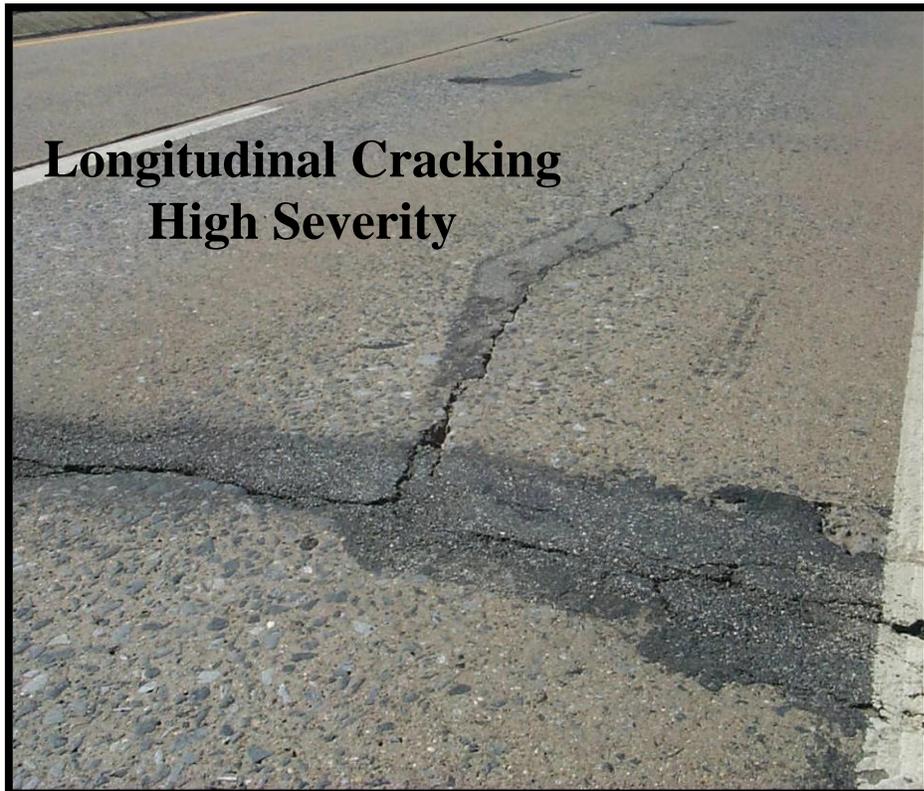
A 1000-foot STAMPP segment has 16 slabs with 2 slabs showing longitudinal cracking in the medium severity category and 5 in the high severity category. The rating for this segment is: 9 slabs none, 2 slabs medium severity and 5 slabs high severity longitudinal cracking.

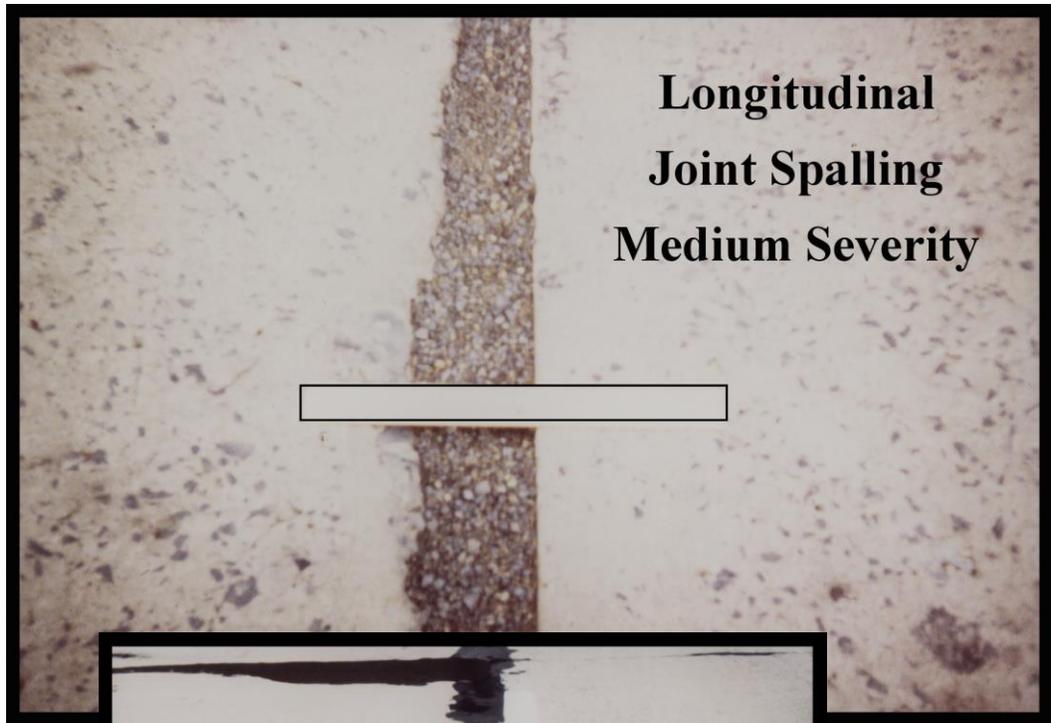
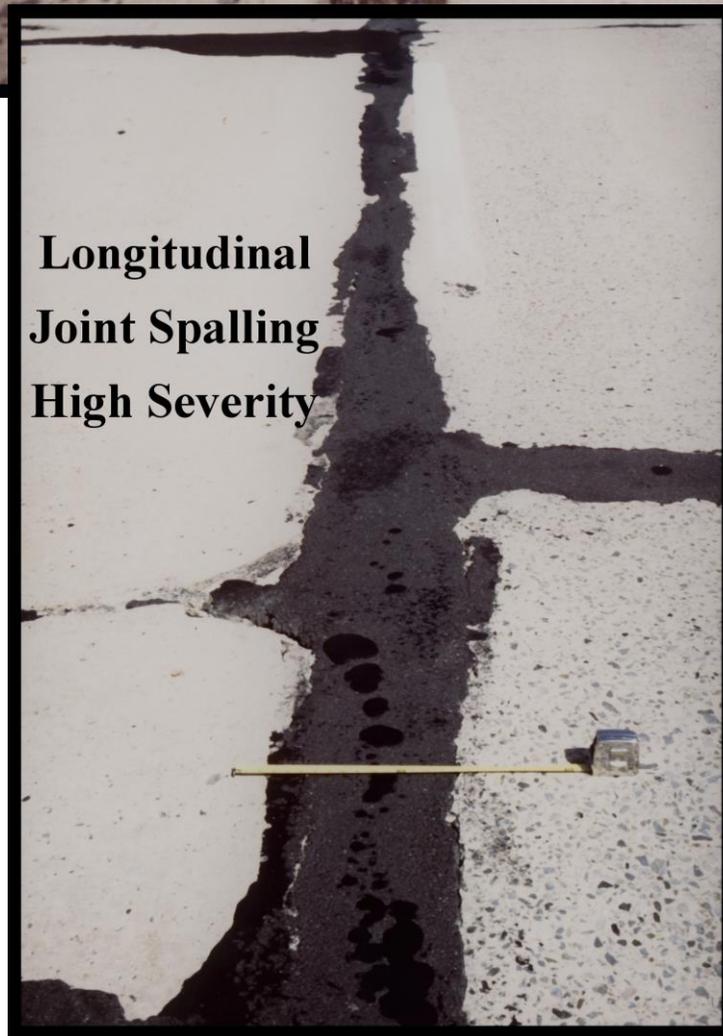
The accumulated length of spalling on a 1000-foot STAMPP segment is broken down into the following two amounts: 200 feet of medium severity and 150 feet of high severity longitudinal joint spalling. The rating for this section is 650 ft none, 200 ft medium and 150 ft high severity longitudinal joint spalling.

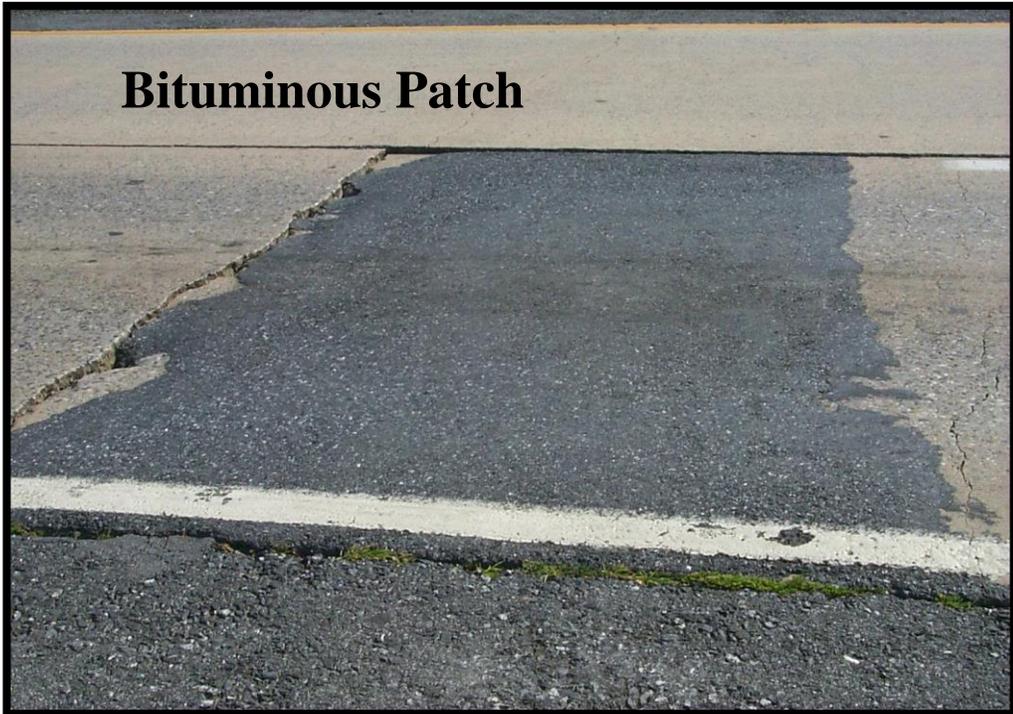
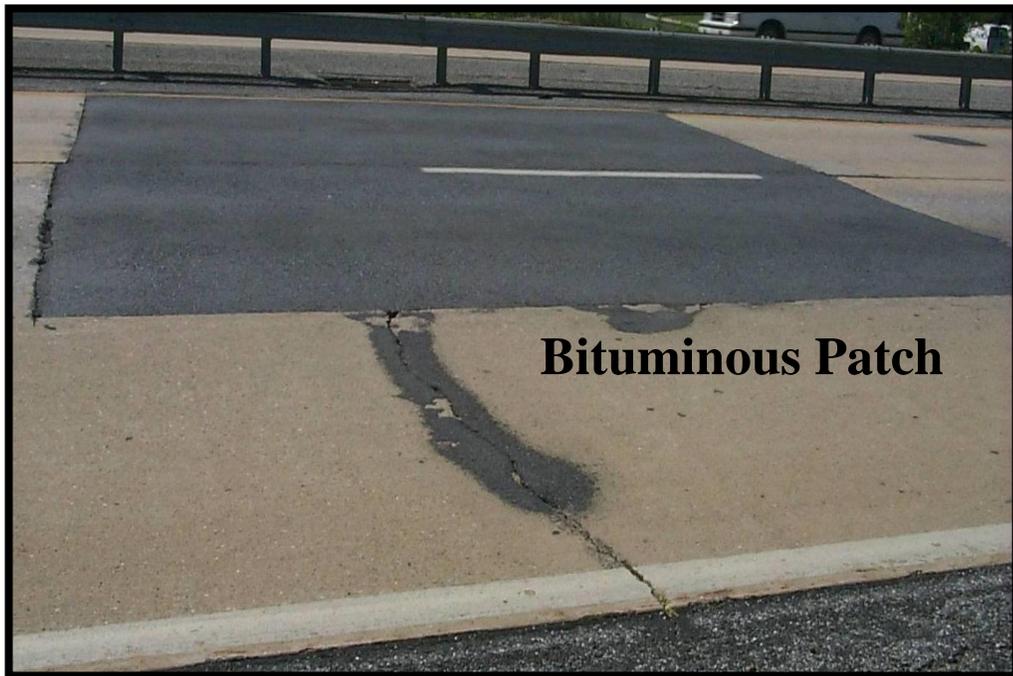
A 1000-foot long, 11-foot wide STAMPP segment has three bituminous patches. One of the patches is 1 foot long and six feet wide (6 ft²), the second is 7.4 feet long and half a lane width (40.7 ft²) and the third is 9 feet long and a full lane width (99.0 ft²). The rating for this STAMPP segment is two bituminous patches and 139.7 ft² area.

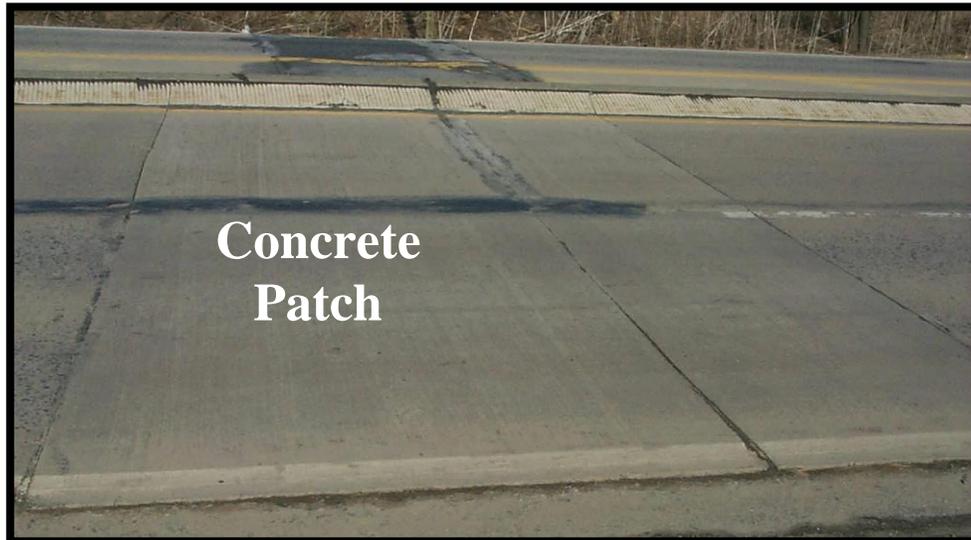
A 1000-foot long, 11-foot wide STAMPP segment has three portland cement concrete patches. One of the patches is 2 feet long and 5 feet wide (10 ft²), the second is 8.2 feet long and half a lane width (45.1 ft²) and the third is 6 feet long and a full lane width (66.0 ft²). The rating for this STAMPP segment is two portland cement concrete patches with 111.1 ft² total area.
