BI07-3

SAFETY INSPECTION BULLETIN

DECEMBER 2007

**School Bus Exhaust Systems**

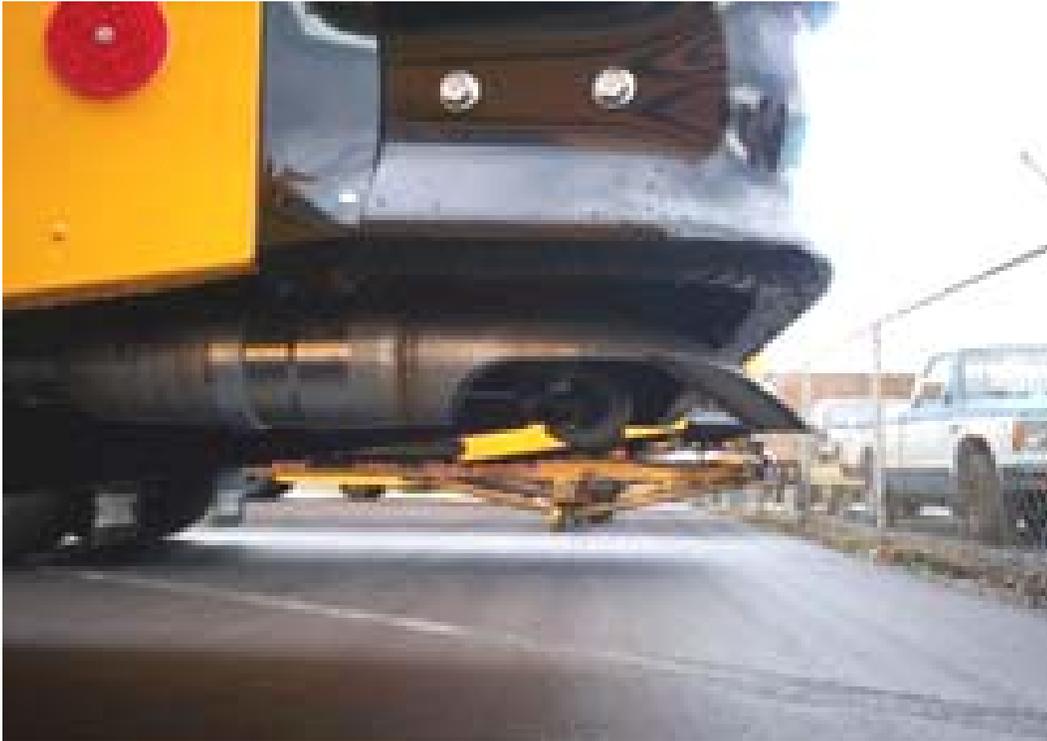
Shoehorn shape of tailpipe used to diffuse and cool exhaust.

After examining these changes, the Department has determined that all school buses originally manufactured with exhaust systems meeting the new EPA standards meet the requirements of both Chapter 171 (School Buses and School Vehicles) and Chapter 175 (Vehicle Equipment and Inspection) as related to exhaust systems. The reverse side of this bulletin contains illustrations of two of the configurations you may encounter.

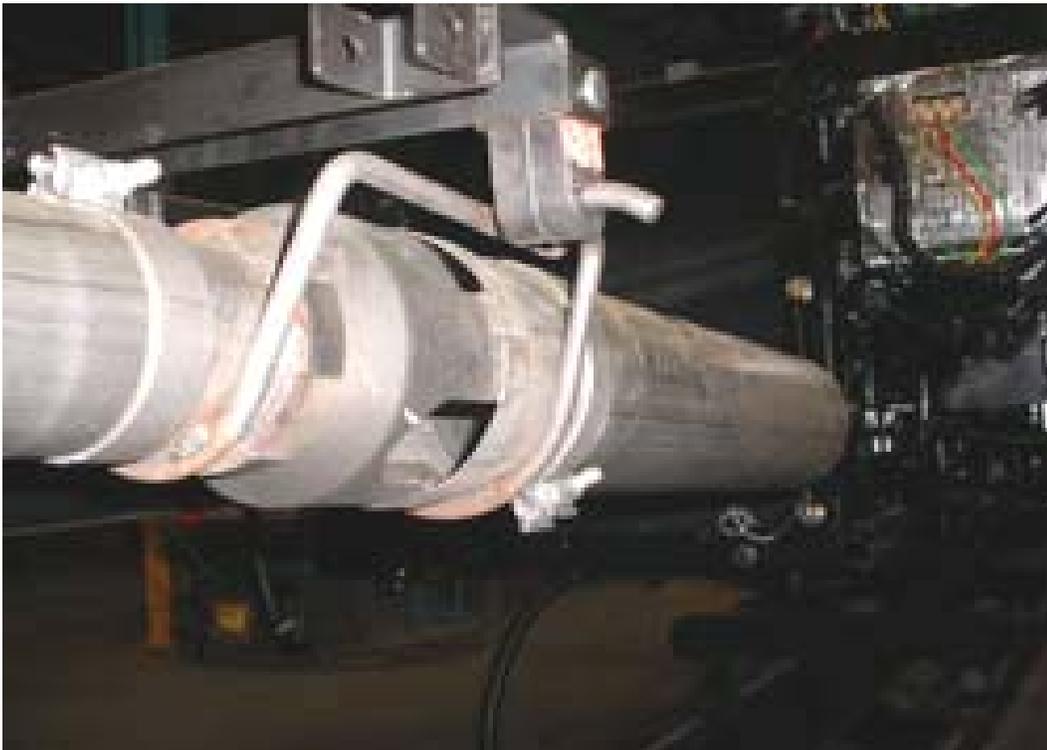
Venturi type system draws cool air into tailpipe to cool exhaust.
